Regional District of East Kootenay

Tie Lake Dam Engineering Assessment

September 2016

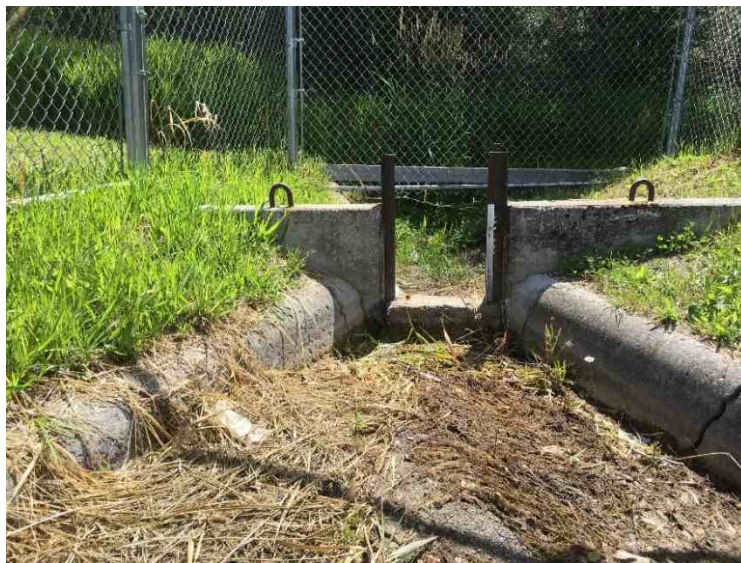
1. **Full Service Level (FSL):** The photos below show the upstream gate invert and inlet condition. At the time of inspection, the normal water level was 100 mm below the invert of the weir. The lake water level appears static, with significant seepage noted on the downstream side. It appears the FSL is assumed to be the weir invert.
 - a. The concrete structure was built with pre-fabricated materials including parking concrete barriers (others in the parking lot). The concrete has deteriorated, and it appears (as expected) that the barriers are not constructed from structural concrete, nor do they appear to contain much reinforcement.
 - b. The steel weir channel and measurement appear newer. This restricts the opening to 450mm.

Photo 1.1 Outlet Structure – Upstream looking south

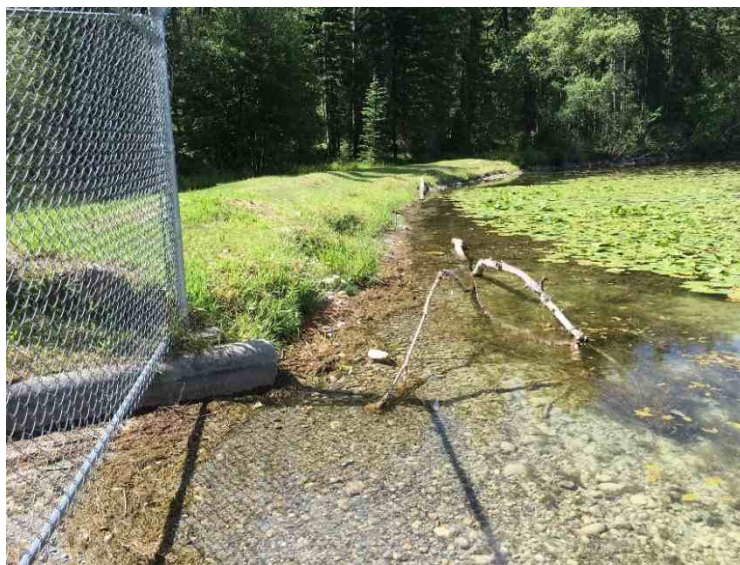
Photo 1.2 Outlet Structure: Looking West. Note stagnant and shallow water.

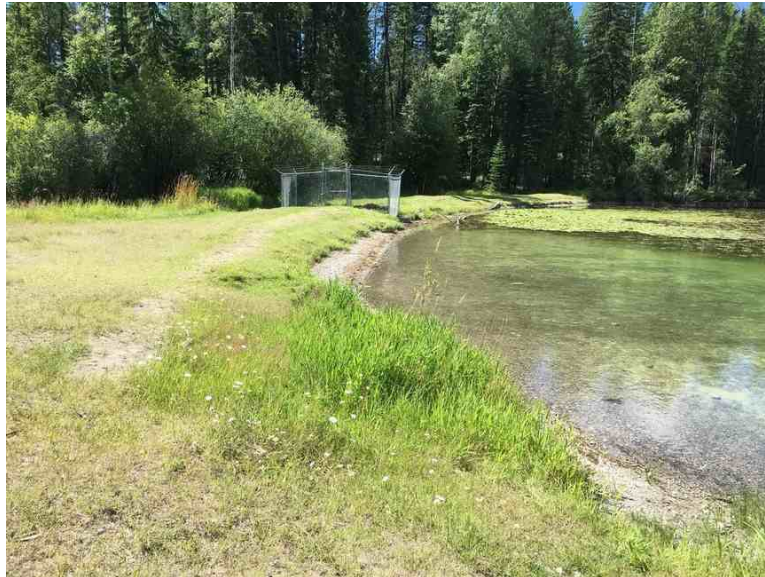
2. **Dam height and composition:** Measurements, taken roughly during the visit had the dam height ranging from 400 to 700 mm. The top width was approximately 2 metres, with side slopes estimated at 4H:1V. The lake side slope face showed minor topsoil sloughing. From discussions with RDEK staff, the south side of the dam used to have trees and shrubs on it, which helped explain some of the tree trunks, depressions and holes from rotted woody debris. The dam core, which was not excavated during this inspection, appears pervious and constructed with pit run gravel or similar gravel. Other than the depressions from the rotted trees, the top and side slopes of the dam appear stable.

Photo 2.1 Tie Lake Dam – Looking west. West side of dam. Note remnants from 2012 sandbagging.

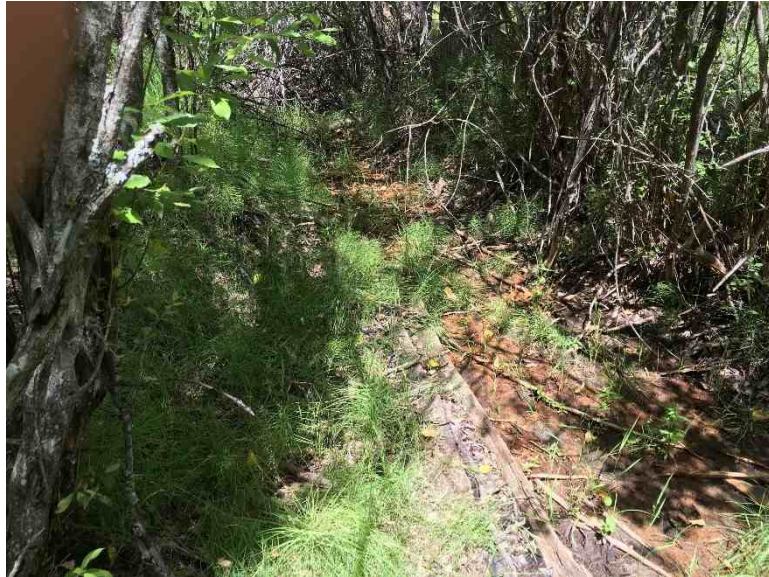
3. **Downstream Conditions:** There is a roughly defined channel downstream, with a culvert under the Tie Lake Shore Road. There is a significant flat area which is boggy. The seepage through the dam maintains this area constantly wet. Note that if a “sunny day” breach of the dam was to occur flood capacity would be restricted by the highway culvert. The road will withstand any temporary storage from a sunny day breach.

Photo 3.1 Remnants of old channel to 600 mm road culvert – Looking South

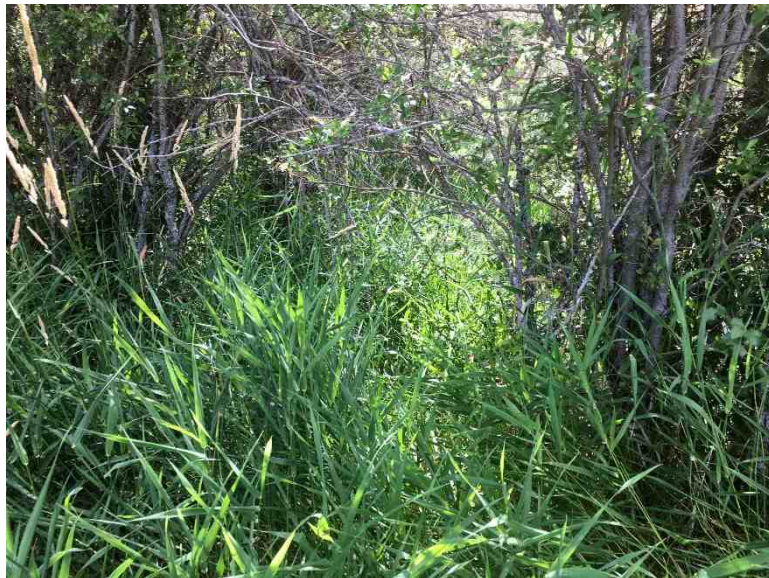
Photo 3.2 Downstream ponding - Looking north

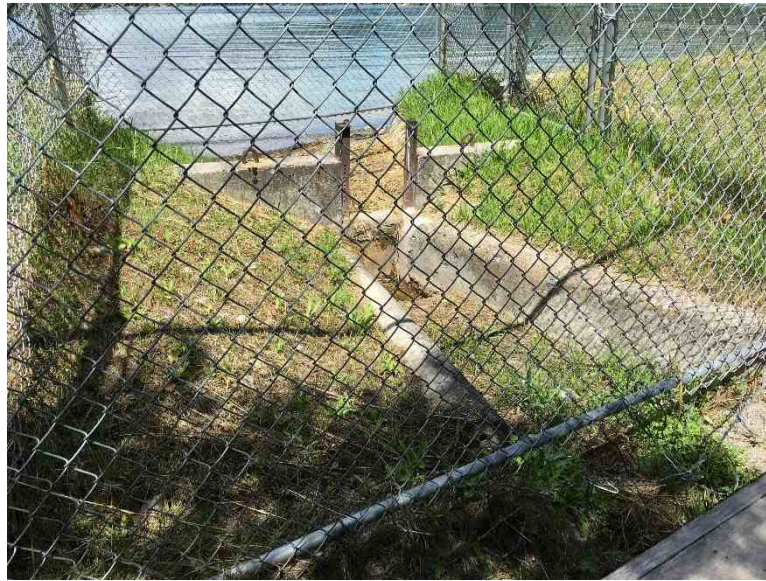
4. **Emergency Spillway:** This dam can be considered to have 3 spillways. The rectangular weir is the service spillway, the flat overflow on top can be considered a second (although the dam isn't high enough to provide this routing capacity), and the third is a 300mm diameter corrugated steel pipe trenched into the dam, approximately 200mm higher than the weir invert. The weir and pipeline appear to be the two official outlet works for the dam.

Photo 4.1 Spillway structure, looking North.

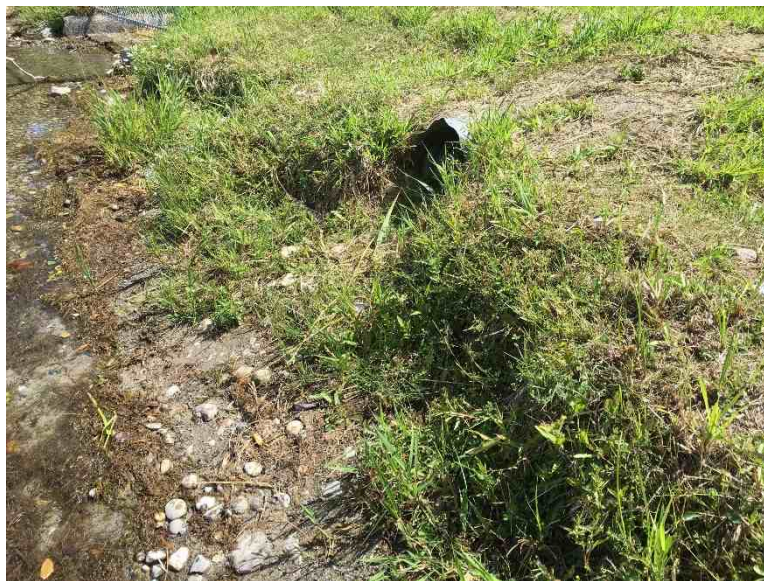
Photo 4.2 CSP Overflow Protection.

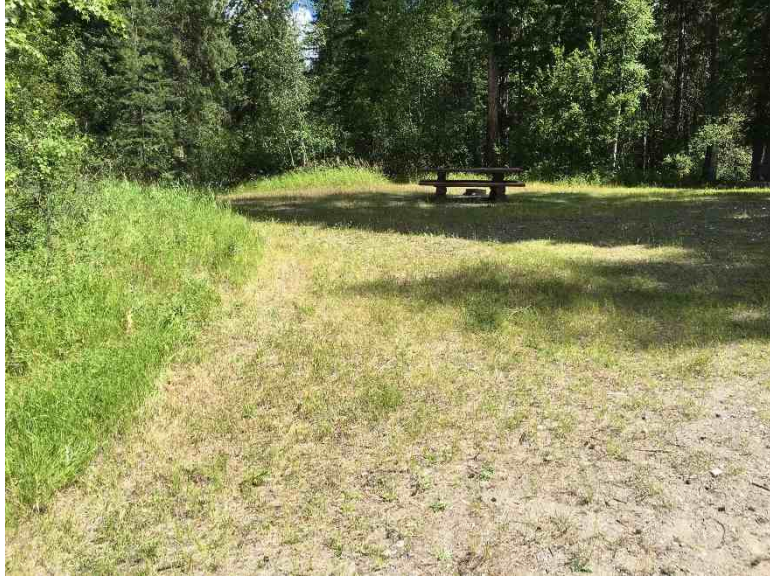
5. **Abutments:** There is just enough height on the abutments to allow the raising of the dam to a minimum 1 metre height.

Photo 5.1 East Abutment. The right abutment of a 1 metre dam would end within the top of the uncut grass on the left.

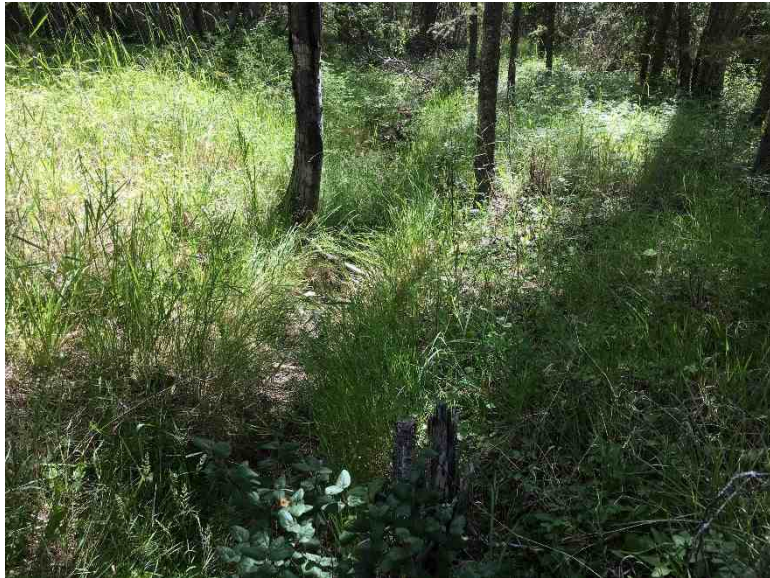
Photo 5.2 West Abutment. Will just be high enough. Some tree clearing will be required.

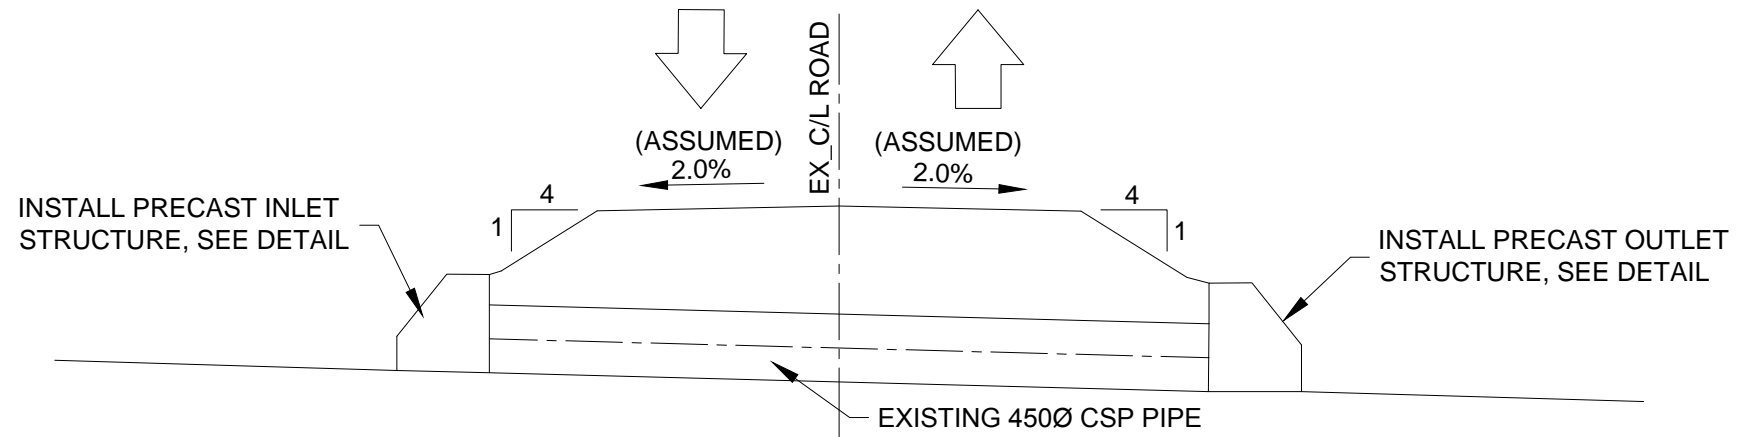
TYPICAL CULVERT CROSSING
SCALE: NTS

- Infrastructure and economics: Low. There is no infrastructure or items of significant value that would be impacted from a failure of the Tie Lake dam. The water intakes in the lake would not be impacted by the 200mm drop in lake water level, and the Tie Lake local road is broad enough to managed the temporary flooding upstream of the highway culvert. It is recommended that the Regional District consider additional armouring both to the inlet and outlet of the culvert to protect against any full flow conditions, as shown on attached Drawing C1003.

The drawings in Appendix B include typical details for armouring of the culvert. The costs to complete this recommended work is summarized in Table 5-3.
