## WINDERMERE CREEK HYDROTECHNICAL ASSESSMENT

Regional District of East Kootenay  
19 – 24<sup>th</sup> Avenue South  
Cranbrook, BC V1C 3H8

2013 January 18  
NHC 3000128

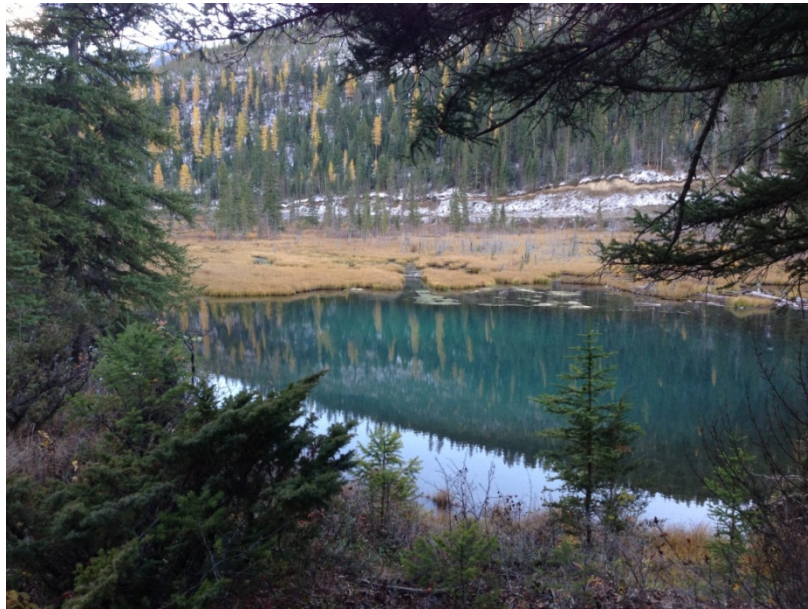
Upstream of Station 9+355, North Windermere Creek branches off the main channel. A large wetland and lake (**Photo 1**) act as a sediment sump on the mainstem above the confluence. It is expected that the wetland also mitigates any water quality changes from upstream activities on the mainstem. Bedload influx from the north fork was observed as channel deposits of gravel and cobble with median diameter 25 mm, ranging up to 200 mm<sup>3</sup>. The channel between Sta. 9+355 and 7+560 was not inspected, however following the site inspection it was suggested by others that there are locations of minor degradation within this reach.

**Photo 1.** South facing view of lake and wetland on south fork of upper Windermere Creek, Sta. 9+677

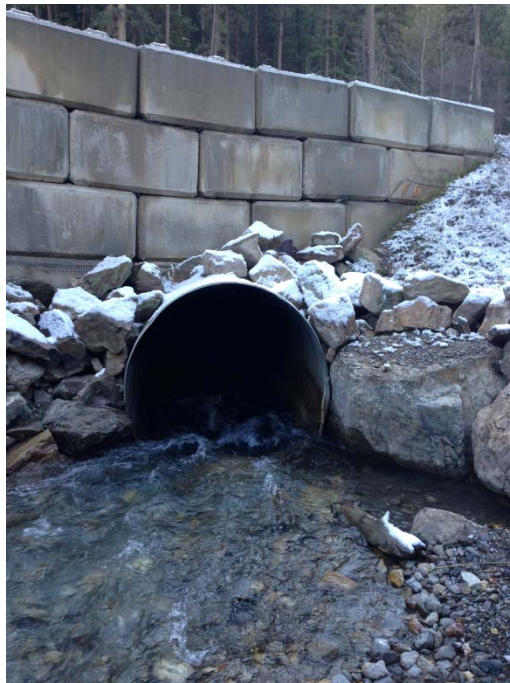
A circular corrugated metal pipe (CMP) culvert at the Mine Road (**Photo 2**) crossing marks the upstream extent of degradation. Vertical banks downstream of the culvert indicate that the channel has likely degraded roughly 0.3 m.

**Photo 2.** Downstream view of the culvert inlet at Mine Road crossing, Sta. 7+560

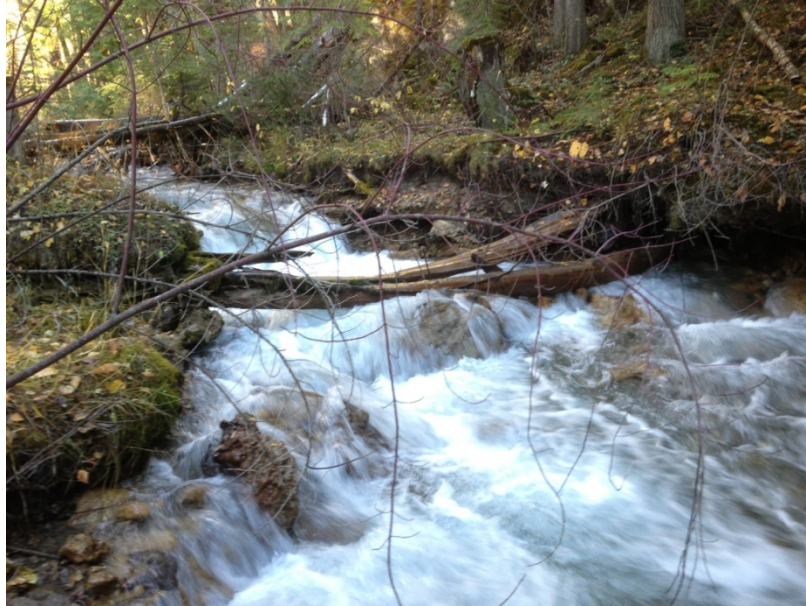
**Photo 3.** Upstream view of nick point in upper Windermere Creek, Sta. 7+170; tufa layer protruding from the bank in photo mid-ground.

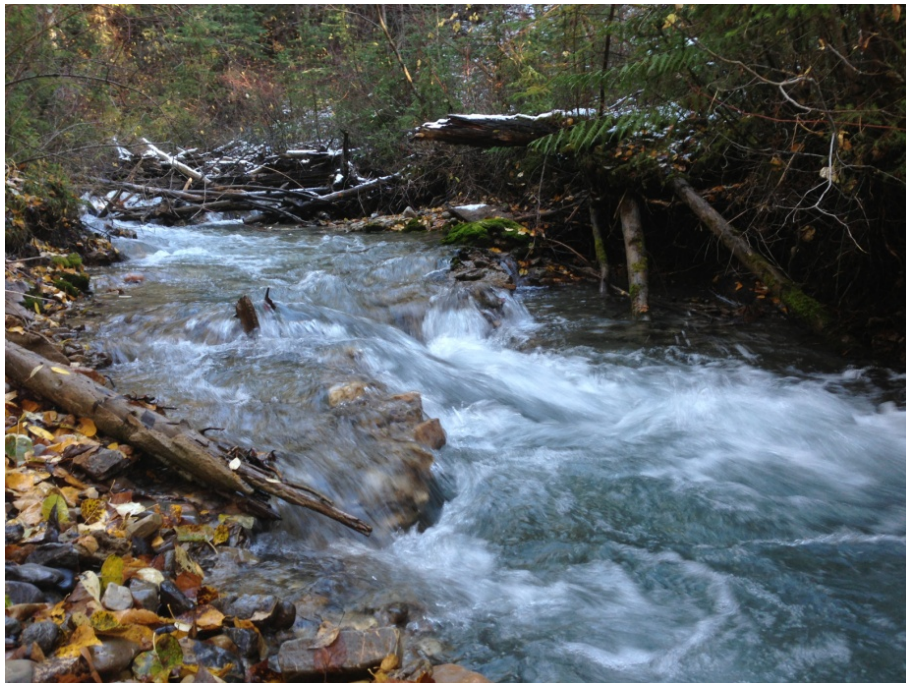
**Photo 4.** Upstream view of small nick point in upper Windermere Creek, Sta. 6+830.

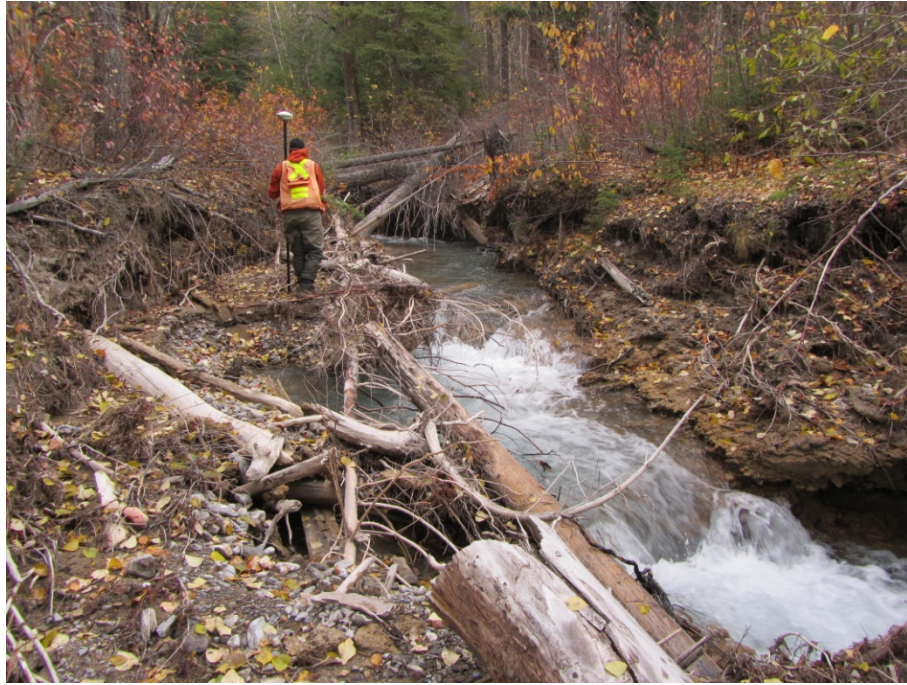
**Photo 5.** Upstream view of third nick point, upstream of the gravel pit and Alpine diversion, Sta. 5+800.

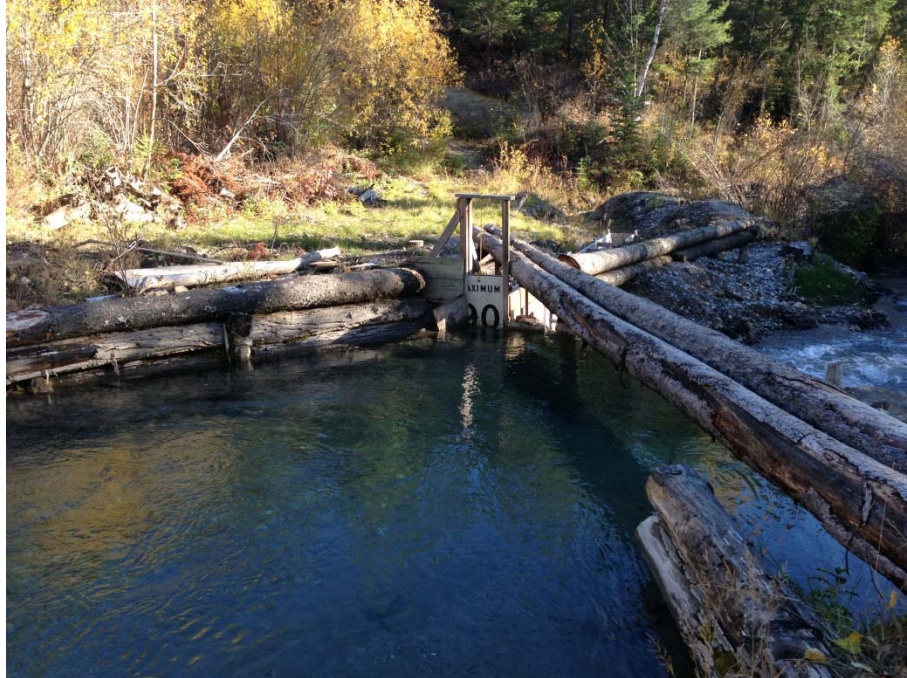
A weir at the apex of the upper fan diverts flow into a constructed diversion channel which supplies water to the Alpine Ranch south of Windermere Creek (**Photo 6**). The weir was damaged in 2011 and was rebuilt prior to the 2012 freshet (pers. comm. D. Wilfley). It does not appear to have been constructed with any scour protection; scour approximately 0.5 m in depth was noted downstream at the base of the weir plate (**Photo 7**).

**Photo 6.** View facing the left bank of the Alpine Ranch diversion weir, Sta. 5+600. The speed limit sign acts as a gate to control flow into the diversion channel.

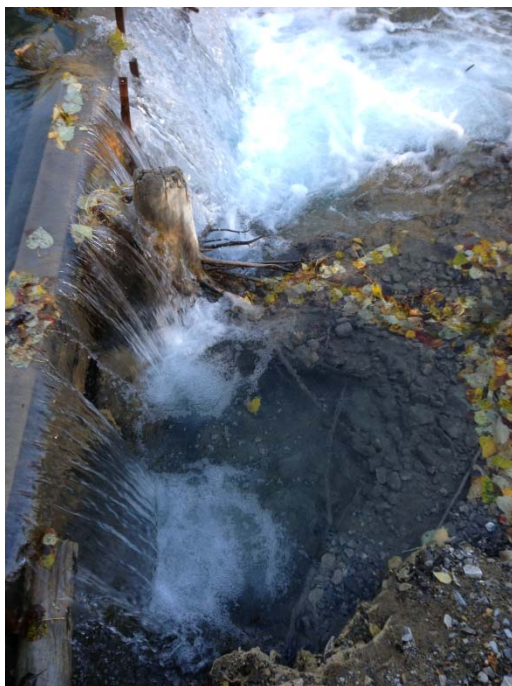
**Photo 7.** Plunge pool at the base of the Alpine Ranch diversion weir, Sta. 5+600.

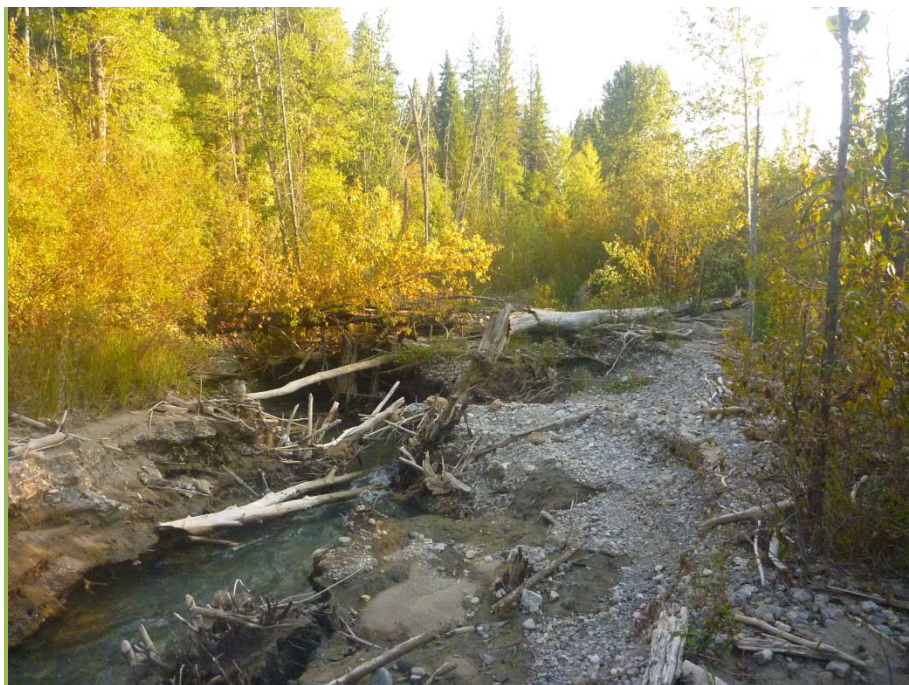
Roughly 80 m downstream of the Alpine Ranch diversion (Station 5+520) channel depth is approximately 2 m and top width is 6 to 7 m (**Photo 8**). Previously at this location, flow was split between the active south channel and the beaver ponds in the floodplain to the right; i.e. the north channel. However, recent downcutting of the south channel has disconnected the wetland. It appears that prior to the degradation of the south channel, moderate to high flows would overtop the south channel's banks and enter the wetland that forms the head of the north channel. This is in contrast to flow entering the north channel through a defined or confined flow split. Debris and sand deposits provided evidence of overland flow on the floodplain, but a defined channel was not present.

**Photo 8.** Downstream view of the upstream end of the South channel, Sta. 5+520. Water previously flowed into the beaver pond complex at on the right, but channel incision on the left has disconnected the floodplain.

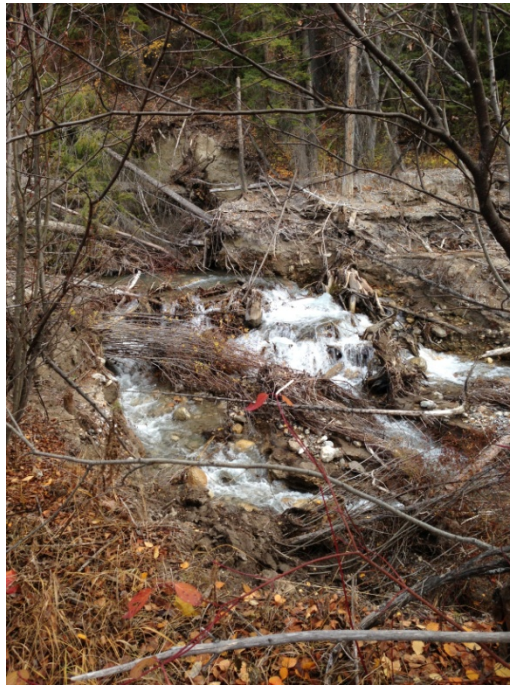
Further downstream (approx. Sta. 5+460), the channel widens to approximately 14 m (top width) and is about 1.6 m deep. At about Sta. 5+400, there is a series of steps forming a nick point approximately 2 m in height (**Photo 9**). At this location, the channel has widened to 20 m following the recent degradation, and is left with vertical banks, as high as 4 m.

**Photo 9.** Upstream view of nick point at Sta.5+400; channel widens to about 20 m and deepens to 4-5 m downstream of this point.

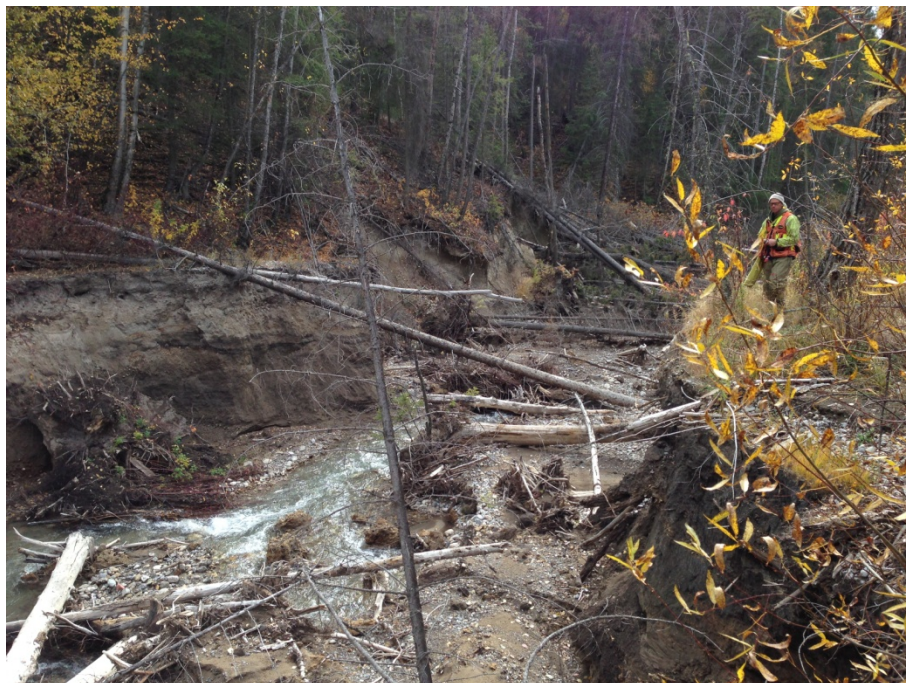
Another nick point was noted at approximate 100 m downstream, Sta. 5+360. A small terrace is visible throughout this reach, probably representing the pre-degradation (i.e pre-2011) bed level (**Photo 10**). The downstream channel is deeper and wider, generally being more than 20 m wide and 5 m high (**Photo 11**). Another nick point approximately 1.5 m in height is located roughly 200 m downstream of the last one, at approximately Sta. 5+085 (**Photo 12**).

**Photo 10.** Downstream view at Sta. 5+200; small terrace on right bank in photo mid-ground probably represents 2011 post-freshet bed level.

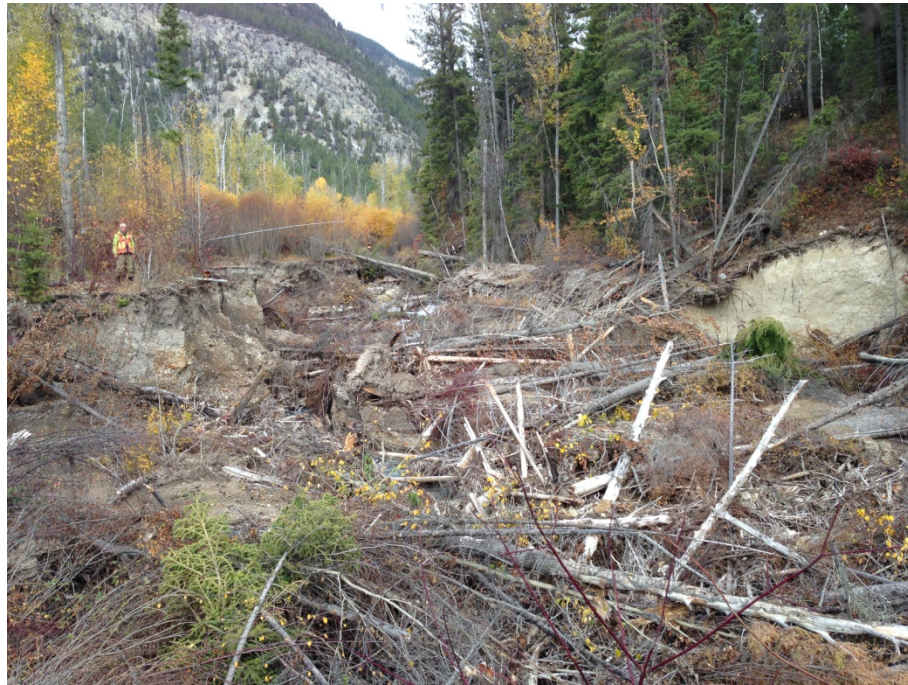
**Photo 11.** Upstream view, Sta. 5+100,; south channel is more than 20 m wide and 5 m deep at this point, and for some distance downstream.

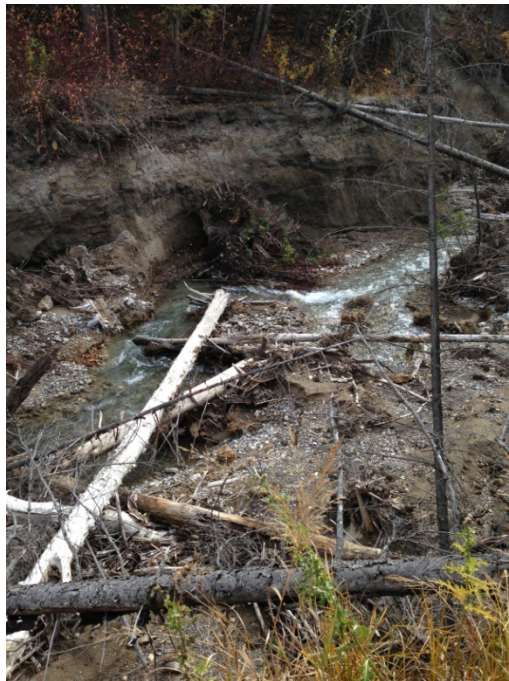
**Photo 12.** Downstream view, Sta. 5+080; nick point in south channel.

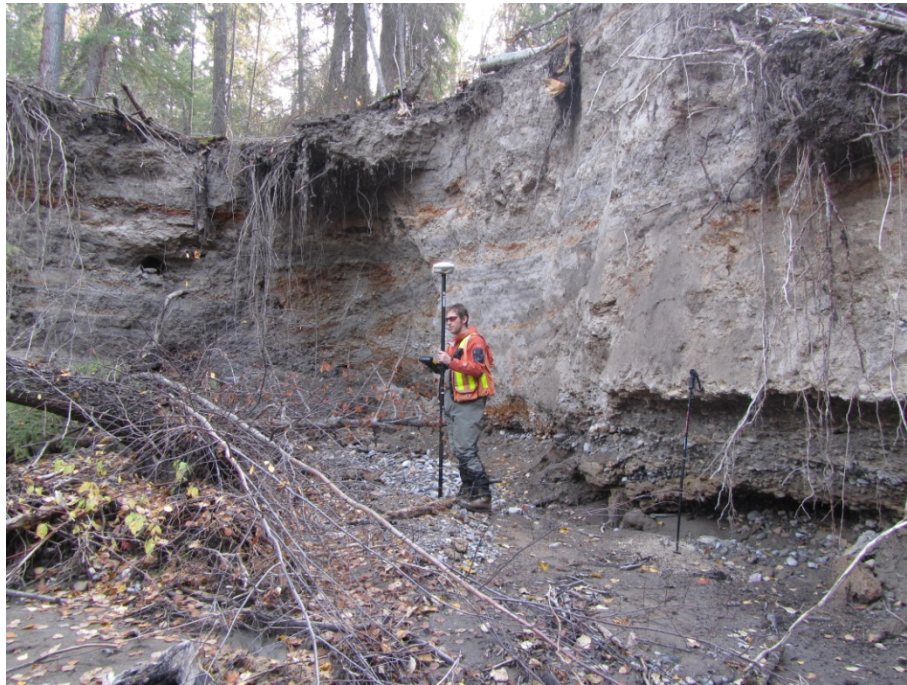
The downstream 100 m of the south channel was inaccessible from the floodplain. Immediately upstream of the confluence, a cut bank approximately 5 m high was noted on the left bank (**Photo 13**), remnant of the recent degradation.

**Photo 13.** Upstream view of severe erosion on left bank of south channel immediately upstream of confluence, Sta. 5+100. Height of bank in photo is approximately 4 m.

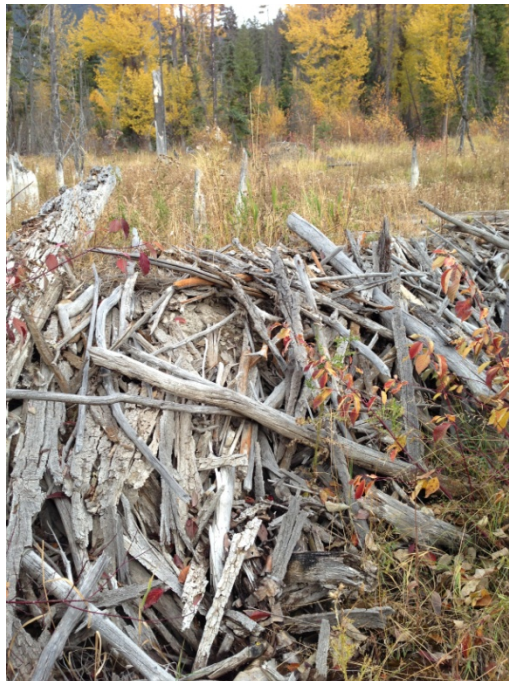
**Photo 14.** Eastward (upstream) view of a beaver dam in wetland. Ground level upstream of dam is roughly 0.5 m higher than downstream.

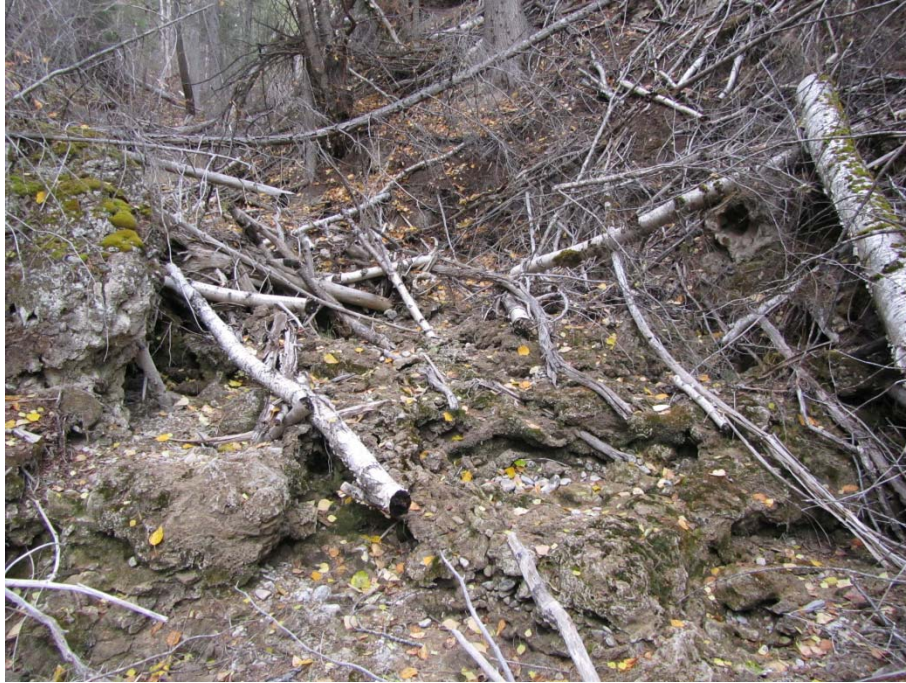
**Photo 15.** Upstream view of the tufa falls in the north channel near its confluence with the south channel, Sta. 5+000.

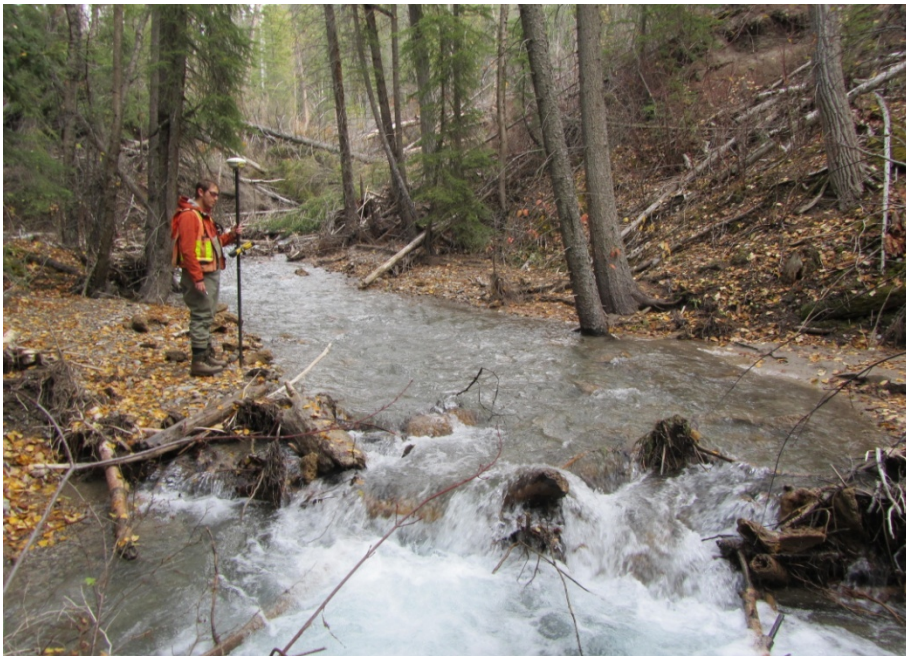
**Photo 16.** Upstream view of aggradation upstream of a small LWD grade control indicated by the buried roots of the wetted tree on the left bank (photo right); Sta. 4+980(immediately downstream of north-south channel confluence).

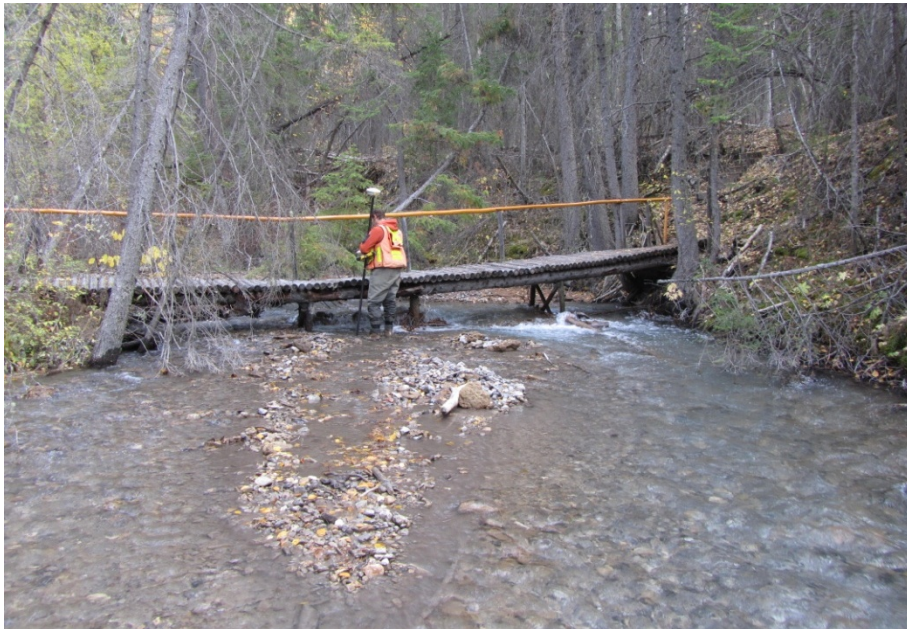
**Photo 18.** Upstream view showing aggrading bed upstream of WVGC weir, Sta. 4+650. Note buried bridge piers.

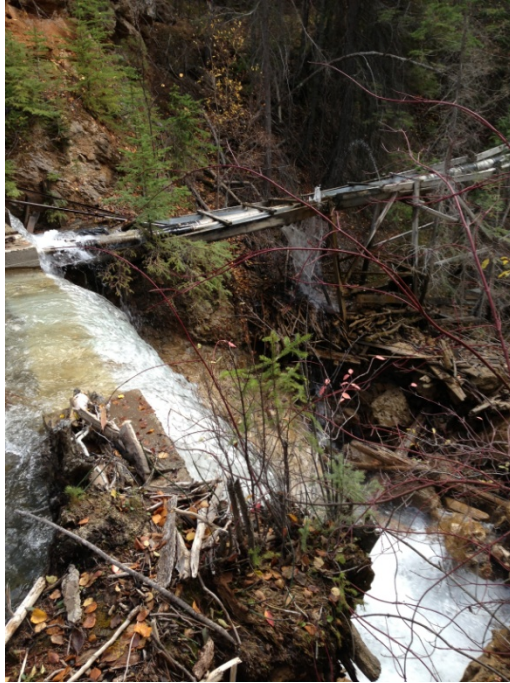
The present height of the crest of the structure with respect to the natural downstream channel bed is approximately 6 m. Further downstream bed degradation and headcutting could increase the height beyond 7.5 m, the threshold for the weir being considered a dam under the British Columbia Dam Safety Regulation. Regardless of height, classification of the failure consequence of the weir as *significant* or greater due to the potential for economic or human losses could also result in classification as a dam. In either case the weir would be subject to dam design, maintenance, and inspection requirements.

**Photo 19.** WVGC weir drops 6 – 7 m, Sta. 4+600; diversion pipe is visible in background.

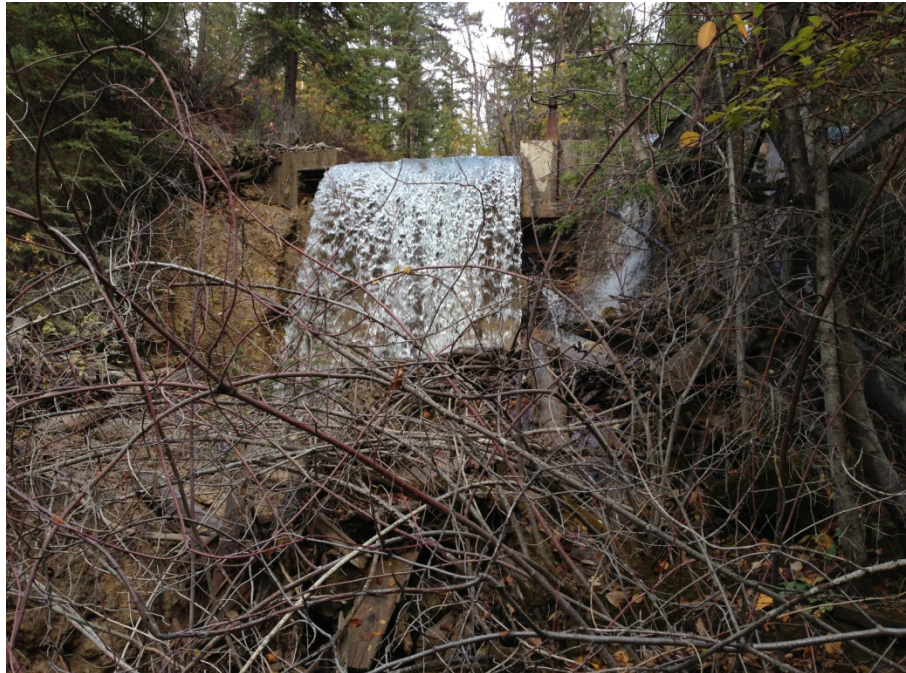
The WVGC weir was apparently built on an existing waterfall, potentially composed of tufa or other calcium carbonate deposit. Water flowing over the weir drops 4 to 5 m to a plunge pool below then travels down a chute and over another step carved into the tufa (**Photo 19**). The tufa layer armouring the channel downstream of the falls appears to have deteriorated in recent years. Depending on the founding of the weir and the underlying falls, upstream progression of the deteriorated channel armouring could undermine the falls and weir and eventually result in the weir's failure.

The WVGC weir maintains the grade for the upstream reach. Failure of the weir and falls would result in degradation of the upstream channel. The degradation could be deeper than 4 to 5 m and propagate a large distance upstream. This would result in mobilization of large quantities of sediment and potentially de-stabilization of the adjacent hillside.

During the October field assessment, there was flow visible from the bed beneath concrete structure of the weir (**Photo 20**). At the time it was thought the flow was caused by piping through the structure, however anecdotal evidence suggests this may have been flow leaking from the low level outlet. Flow around the sides of the weir was also observed.

**Photo 20.** Base of WVGC weir appears vulnerable to undermining erosion, Sta. 4+590. Water on photo right is mostly leakage from intake pipe, but some flow from beneath the weir structure is also visible, which may be a low level outlet.

downstream reaches greater volumes of sediment than experienced in 2011 and 2012. It is recommended that a qualified professional be engaged to undertake a detailed safety assessment of the weir; primarily how it is supported and the likelihood for failure due to flow outflanking or the structure be undermined by scour.

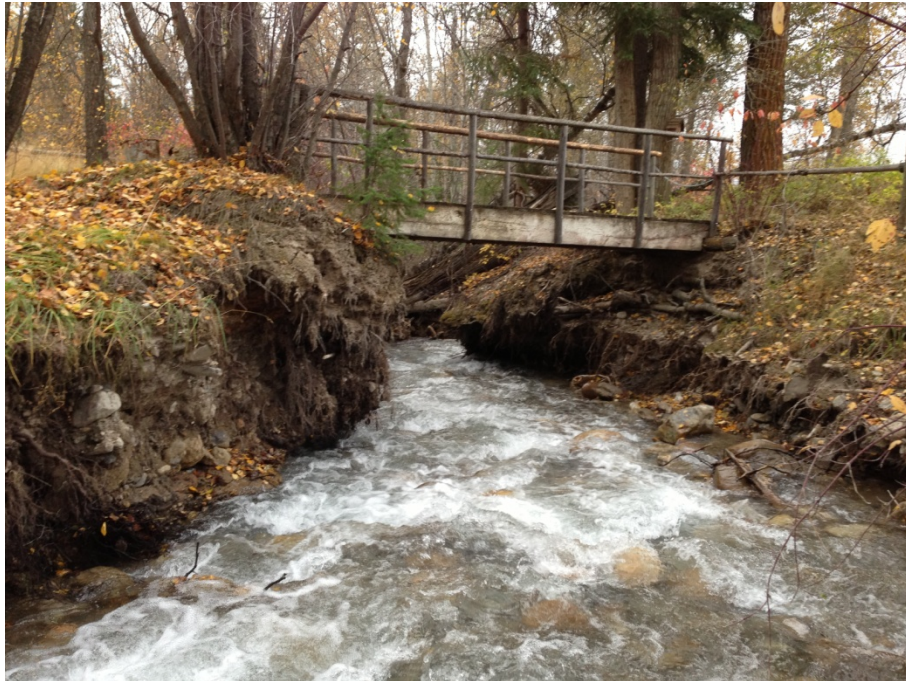
**Photo 24.** Incised channel downstream of Windermere Loop Road culvert, with undercut banks, Sta. 4+100.

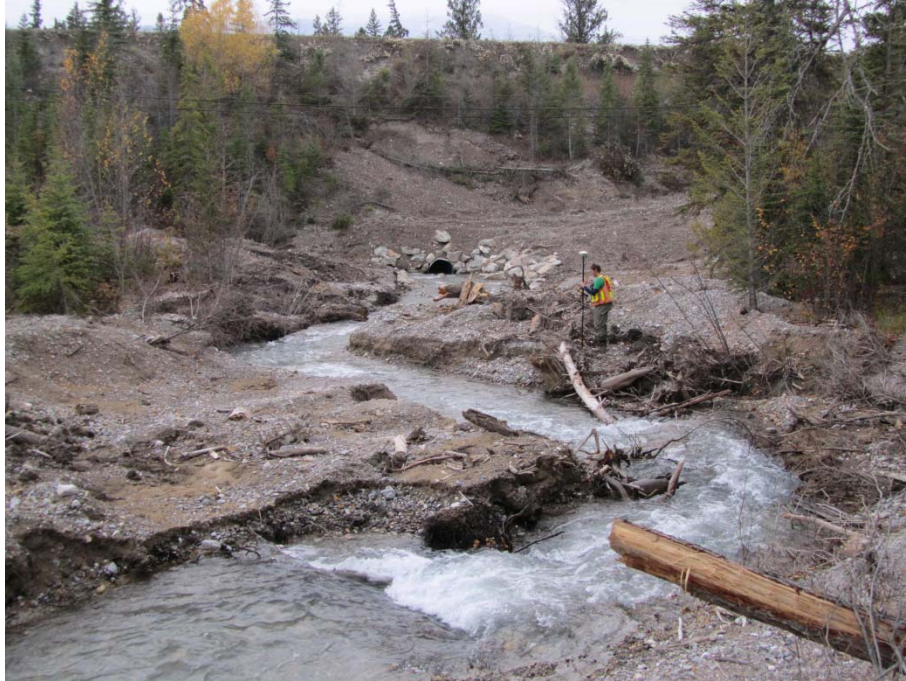
**Photo 27.** Downstream view of sediment deposition in the reach upstream of Highway 93, Sta. 1+650.

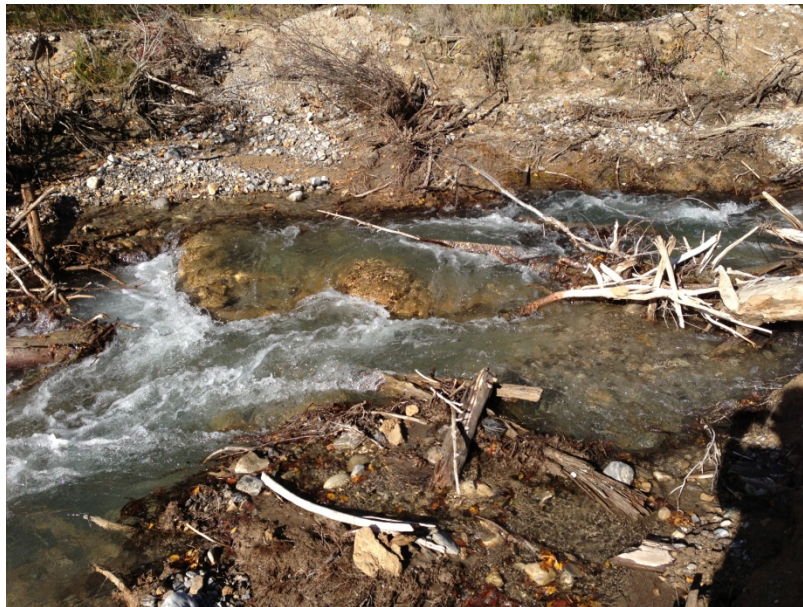
**Photo 28.** Channel incision of 1 – 2 m through sediment deposit upstream of highway 93 has cut down through the tufa layer in some places, Sta. 1+550.

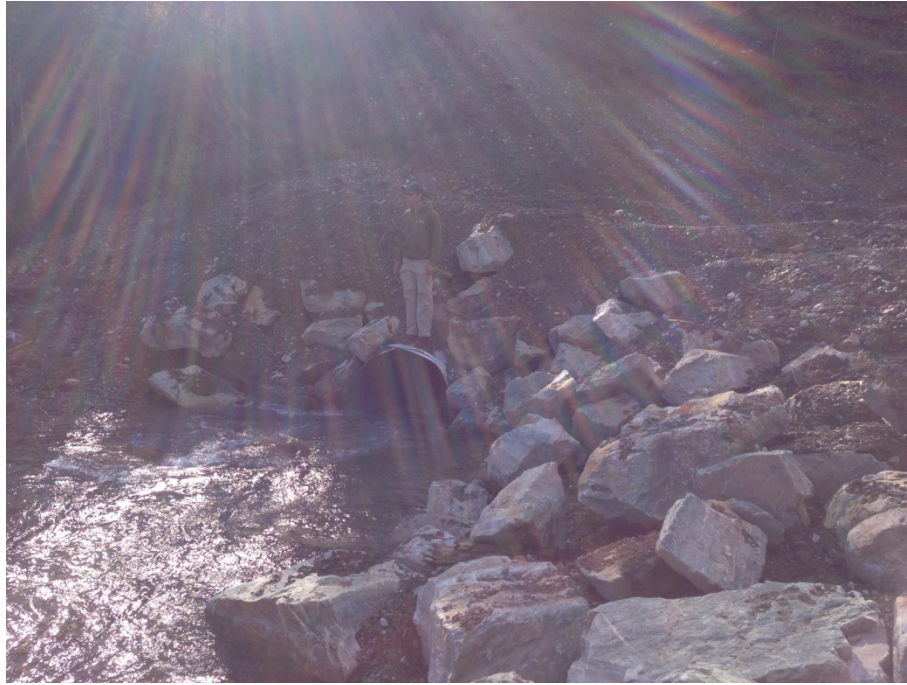
At station 1+500 Windermere Creek crosses under Highway 93. The creek passes under the highway through a 1300 mm diameter CMP culvert set roughly 5 m below the highway surface. The culvert is undersized and partially embedded (**Photo 29**). During high flows, the reduced conveyance capacity of the culvert causes upstream water levels to increase. This backwatered condition results in sediment deposition, that extends about 75 m upstream of the crossing (**Photo 27**). Tufa deposits are visible in the channel bed and banks. The creek has incised 1 to 2 m through the recent sediment deposition and cut below the tufa armour layer in some places (**Photo 28**). Average gradients in the recently degraded channel are 3%, but the hydraulic gradient would be less steep during high water when the culvert backs up flow.

**Photo 29.** Downstream view of Highway 93 culvert inlet, Sta. 1+510.

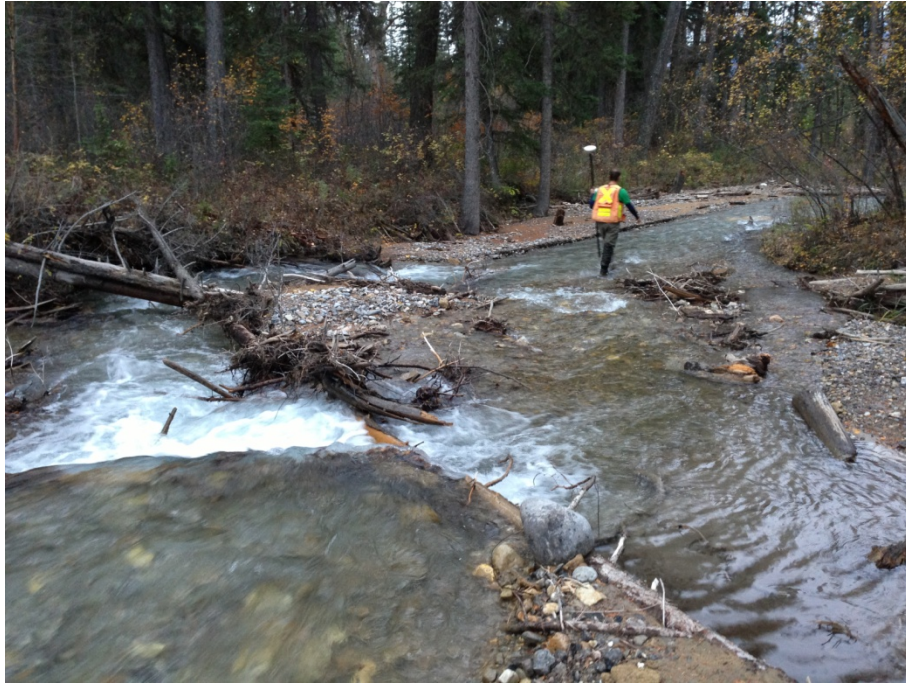
**Photo 31.** Downstream view of channel downstream of Highway 93 culvert, Sta. 1+450; channel is aggrading with shallow banks and woody debris steps.

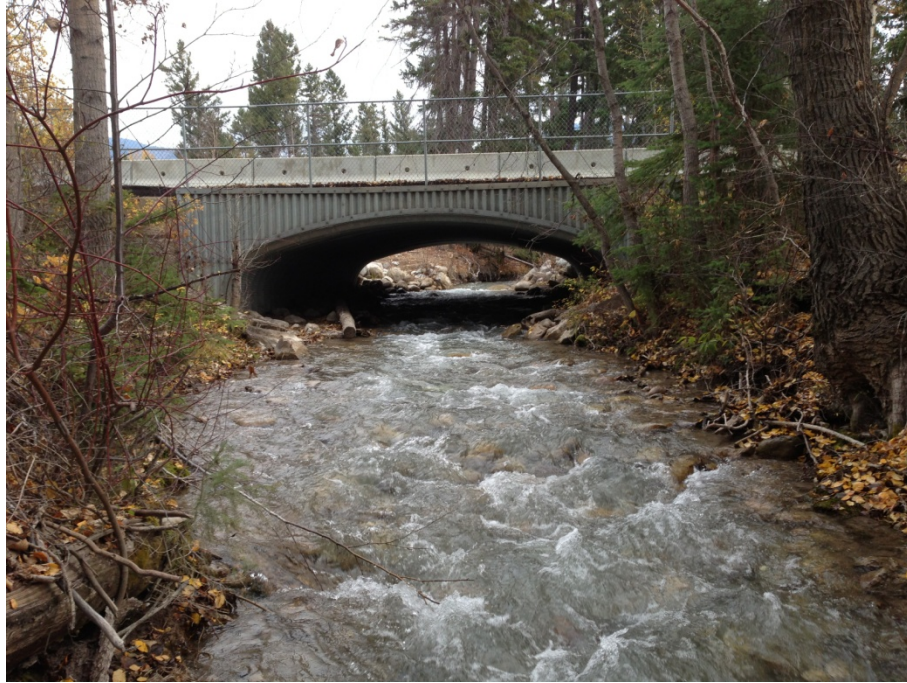
Windermere Creek crosses under Victoria Avenue near Station 0+400 through an 8 m wide by 2.2 m high arch culvert (**Photo 33**). The channel immediately upstream of Victoria Avenue is well established with a width of approximately 3 m and banks about 2 m in height (**Photo 32**). The channel is somewhat incised in comparison to its local banks, but there is no evidence of recent degradation.

**Photo 33.** Upstream view of Victoria Avenue culvert outlet, Sta. 0+370.
