Regional District of East Kootenay (RDEK)

Cold Spring Creek Debris Flow Hazard and Risk Assessment

FINAL REPORT

March 1, 2015

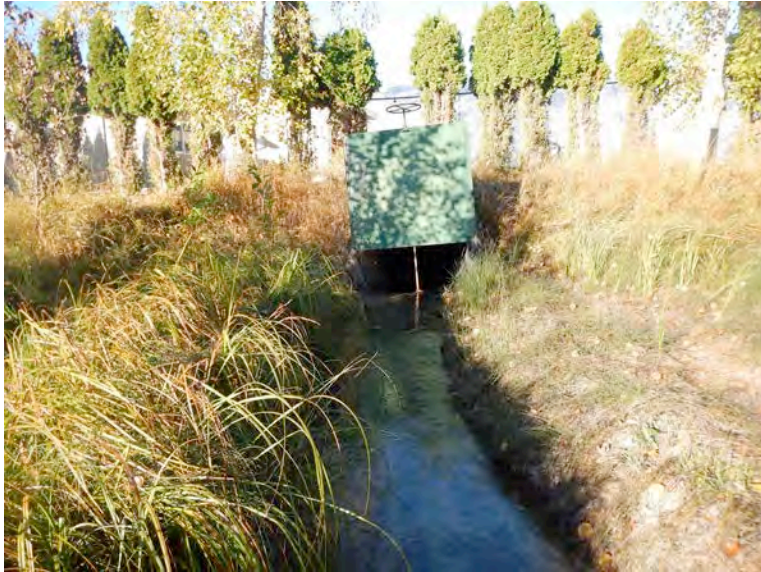
Photo 1: Culvert (1600 mm) and gate at outlet of RDEK Debris Trap (towards Columbia River)

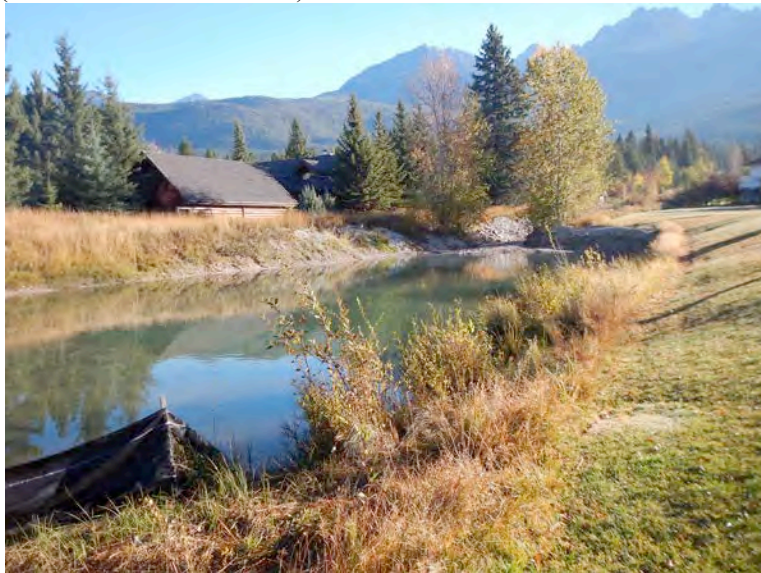
The debris trap was cleaned in 2011 and in 2013 by RDEK (photos showing the 2011 and 2013 condition are provided in Appendix A). There are no historical records of dates and/or volumes removed from the pond.

Photo 2: RDEK Debris Trap

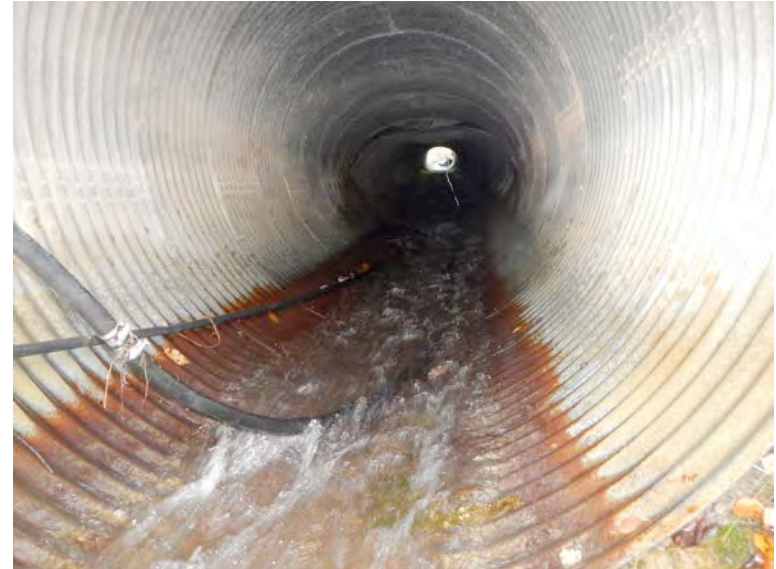
Photo 7: View upstream through Hwy 93/95 Culvert. Note deformation and water lines.

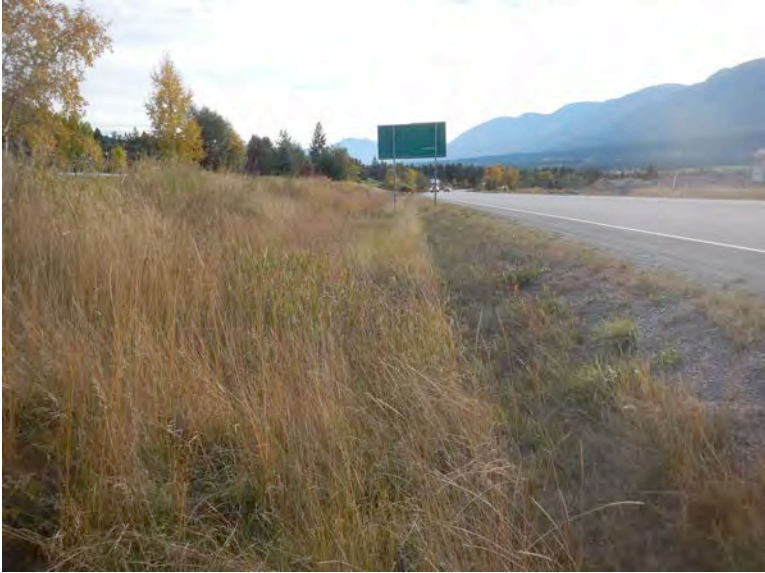
Photo 9: Highway ditch on east side. Downstream of Cold Spring Creek.

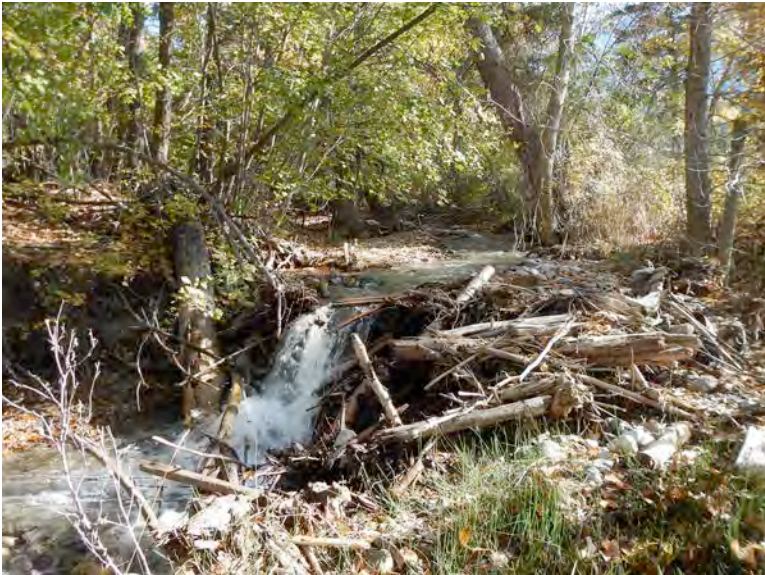
Photo 10: Reach 3. Small debris jams and lack of channel confinement.

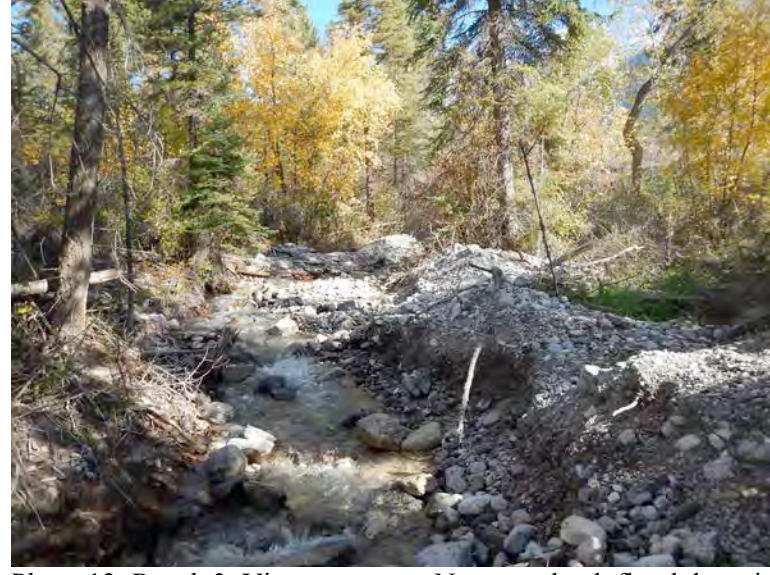
Photo 12: Reach 3. View upstream. Note overbank flood deposits.

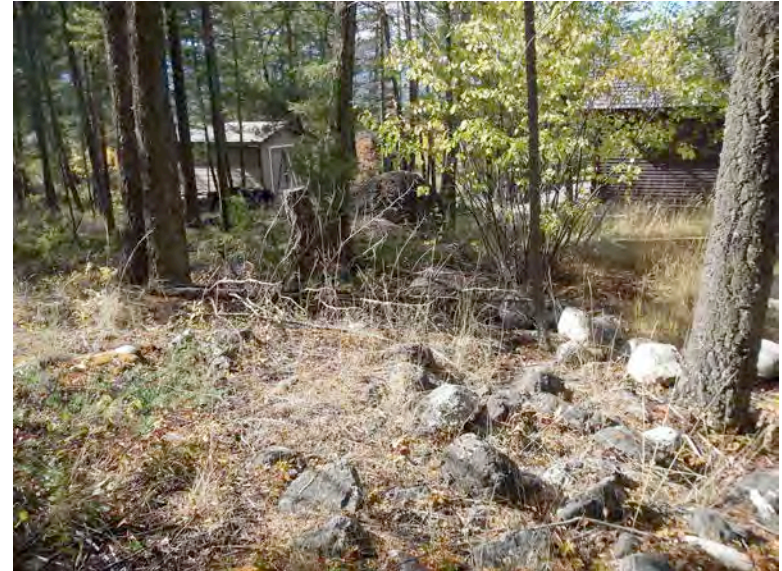
Photo 15: View of scattered boulders in forest at upper end of Cold Spring Creek fan

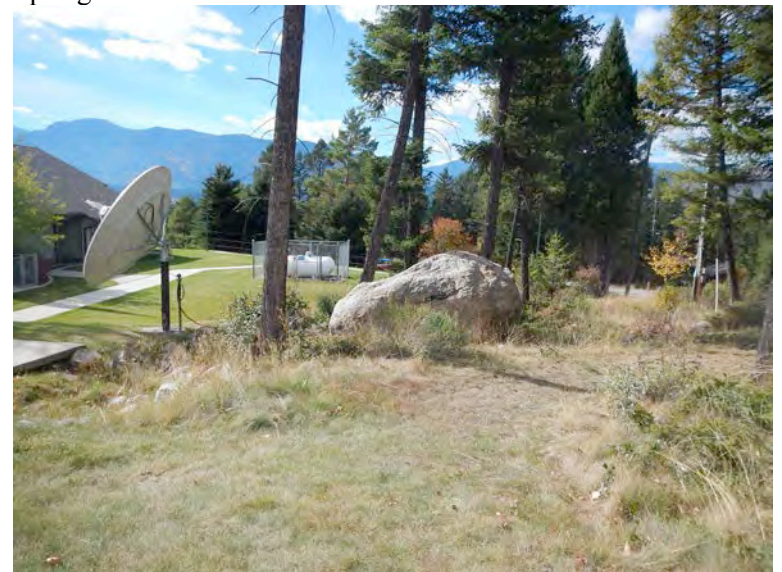
Photo 16: One of several scattered large boulders at upper end of fan

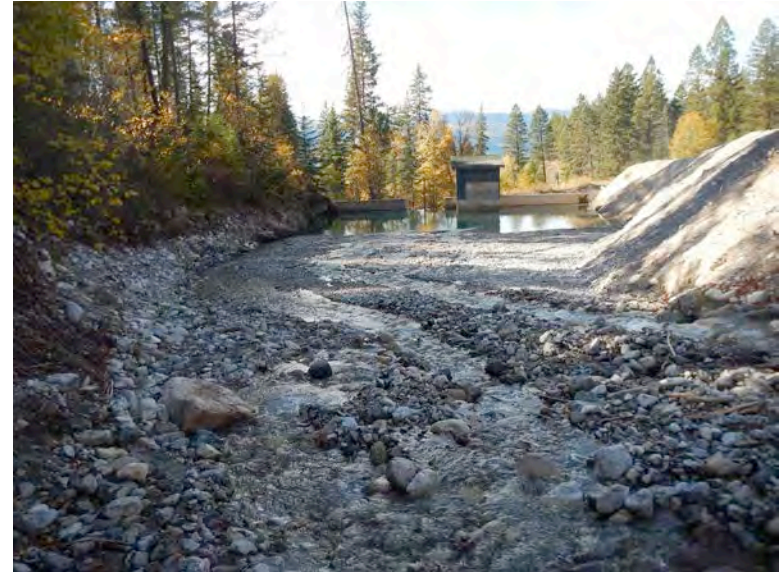
Photo 20: Downstream view of Cold Spring Creek Dam reservoir.
Excavated material on right

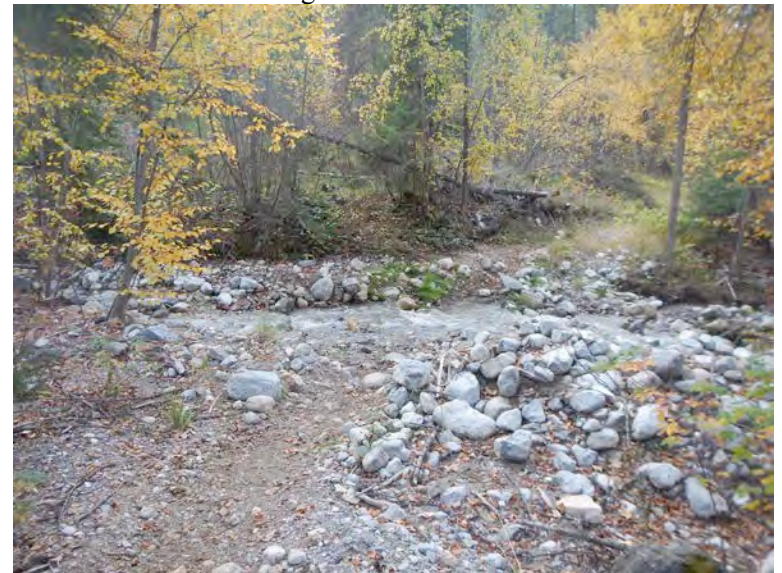
Photo 21: Reach 4. Note debris levee and size of boulders transported
by Cold Spring Creek

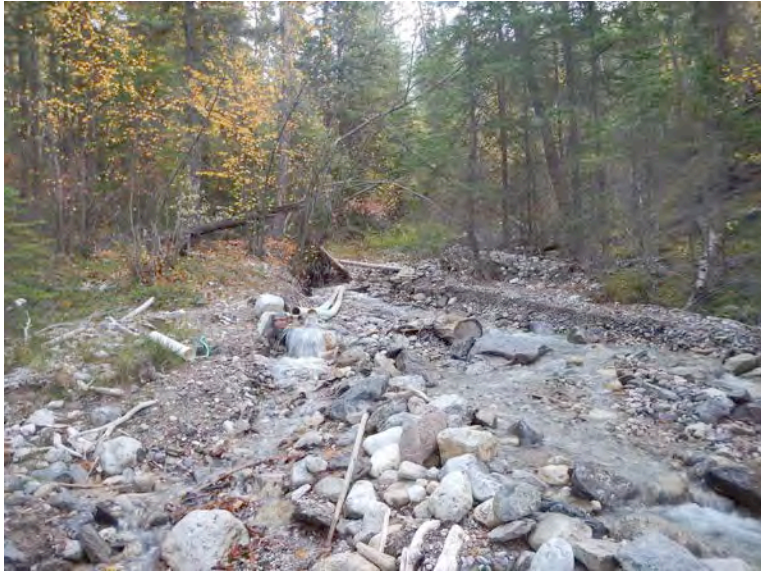
Photo 22: Reach 4. Shallow gradient reach (12-17%) with debris deposition.

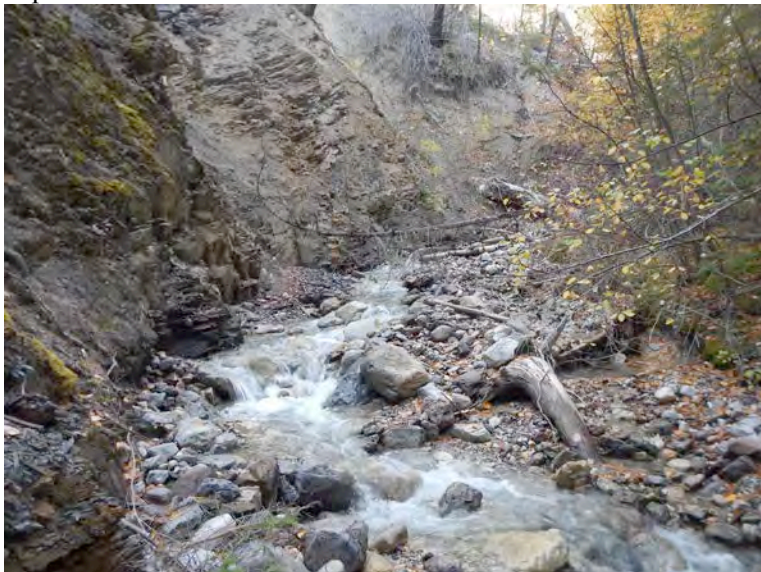
Photo 23: Reach 4. Example of erodible phyllite bedrock along stream bank.

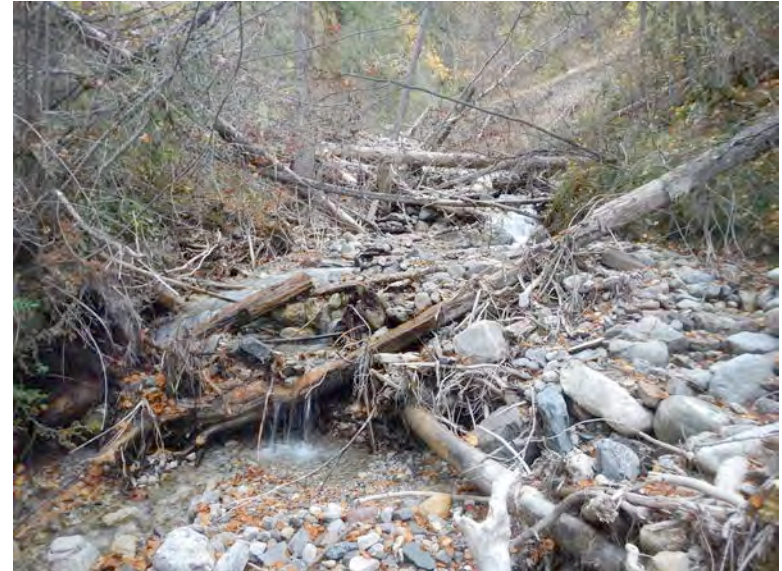
Photo 24: Reach 4. Example of small debris jams and upstream sediment wedges.

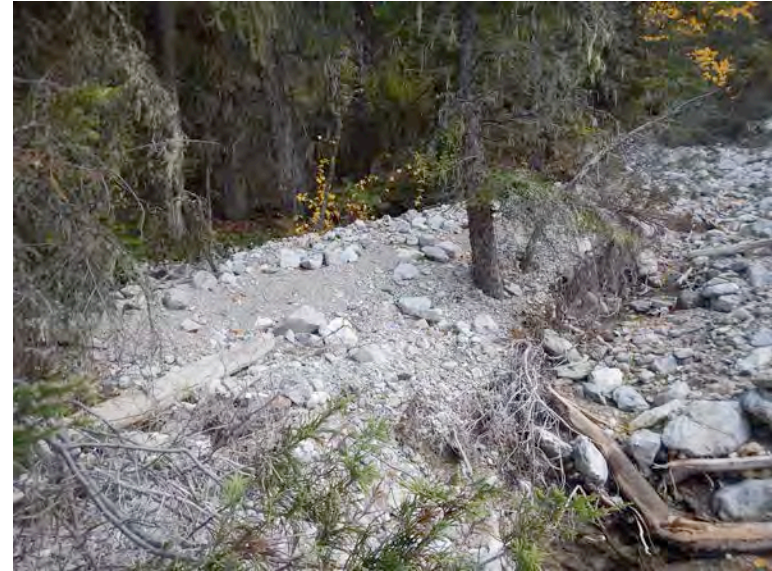
Photo 28: Reach 5. Note overbank sediment deposition.

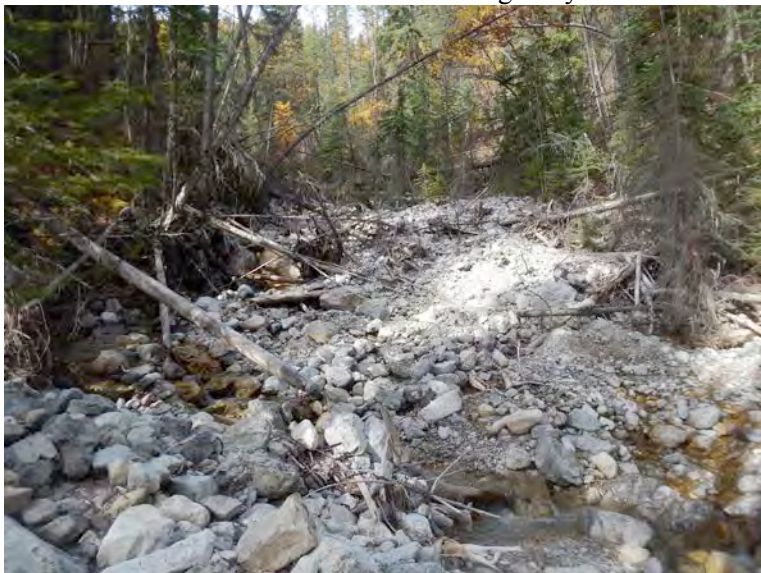
Photo 27: Reach 5. View upstream. Gradients of 18-20%, with abundant stored sediment in channel.

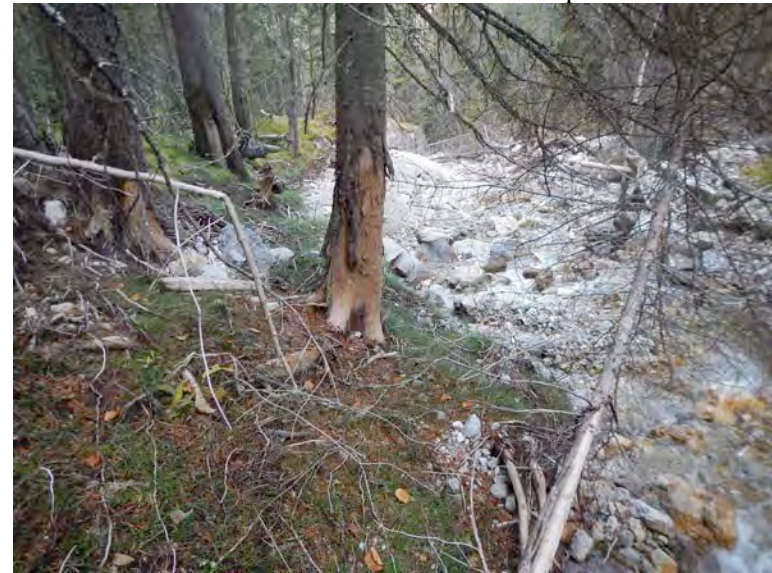
Photo 29: Reach 5. Note impact damage on trees.

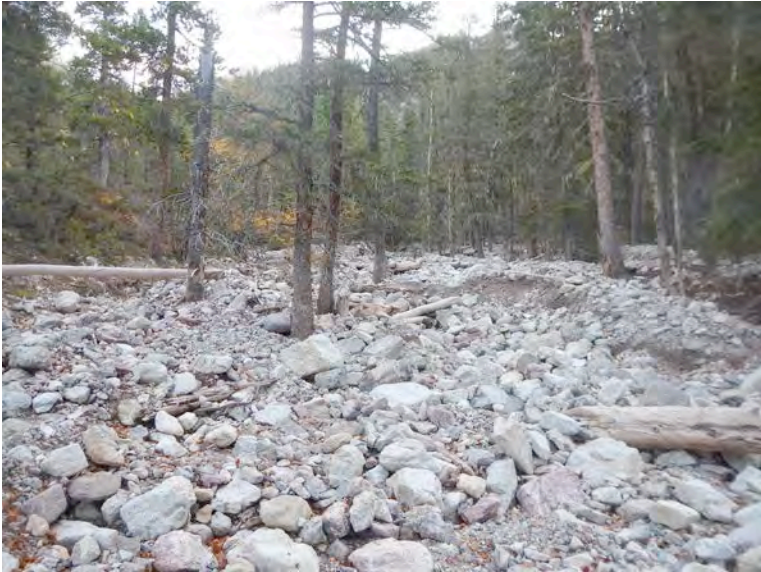
Photo 30: Reach 6. View upstream of abundant stored sediment (streamflow is subsurface)

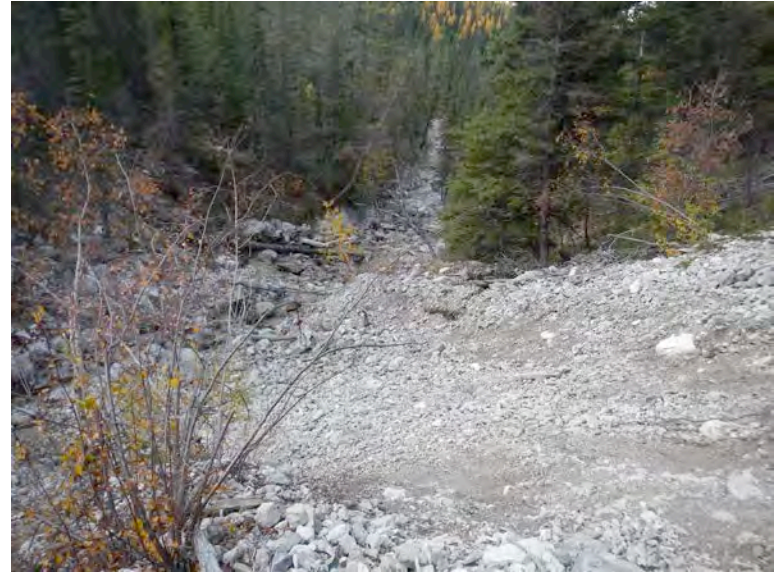
Photo 32: View down debris flow/debris slide gully at confluence with Reach 6

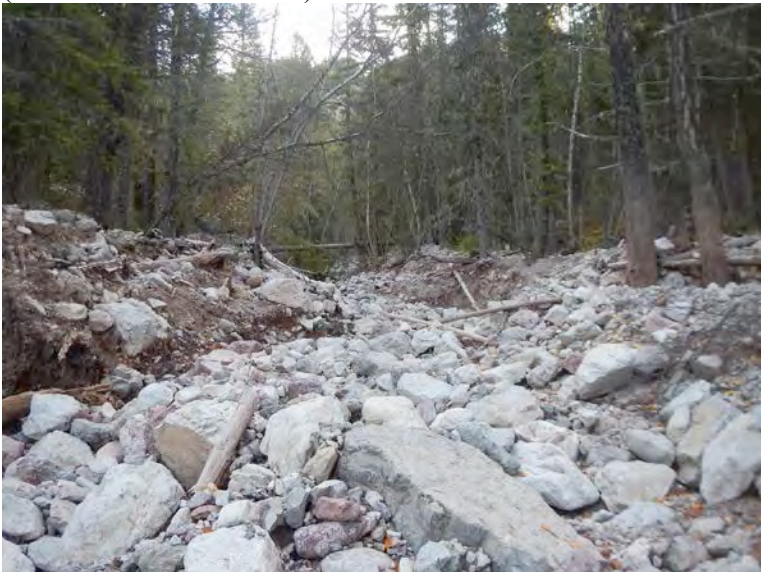
Photo 31: Tributary A. View upstream of abundant stored sediment (flow is subsurface)

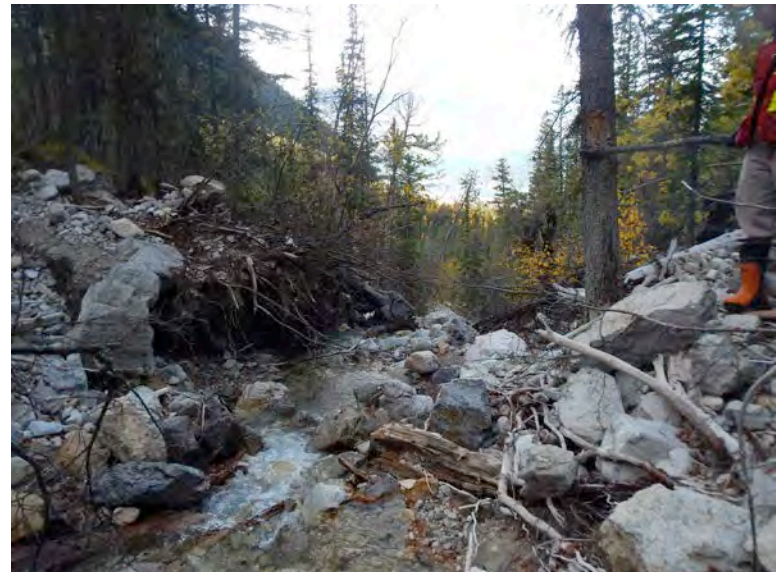
Photo 33: Evidence of small landslide debris dam at the base of gully shown in Photo 32

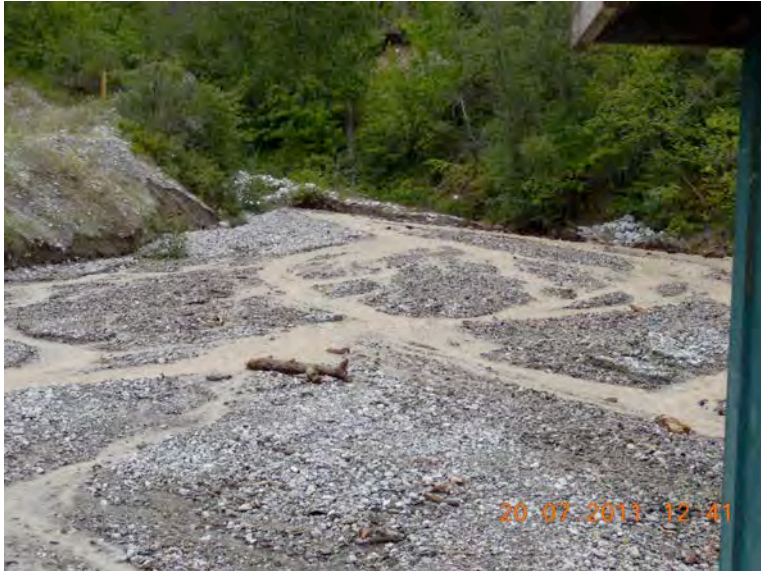
Photo 34: Sediment infilling of Cold Spring Dam reservoir after flood event in 2011 (photo from RDEK)

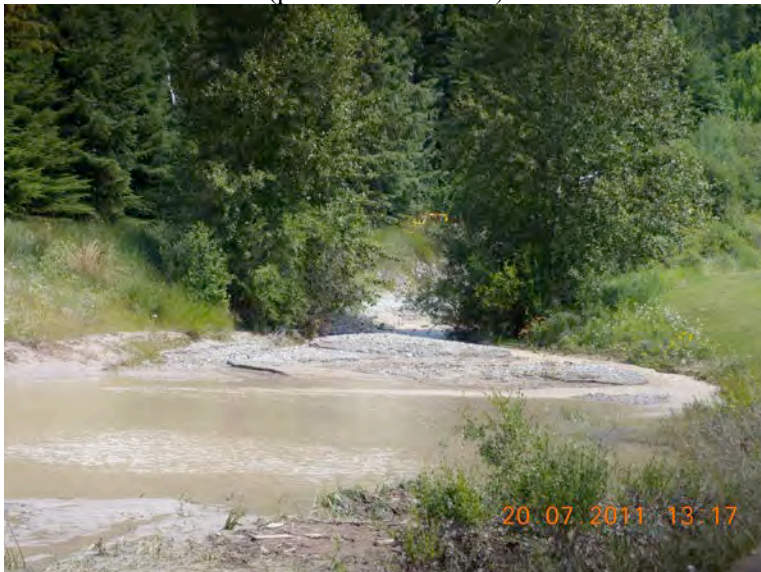
Photo 35: Sediment infilling of lower debris trap on Cold Spring Creek after flood event in 2011 (photo from RDEK)

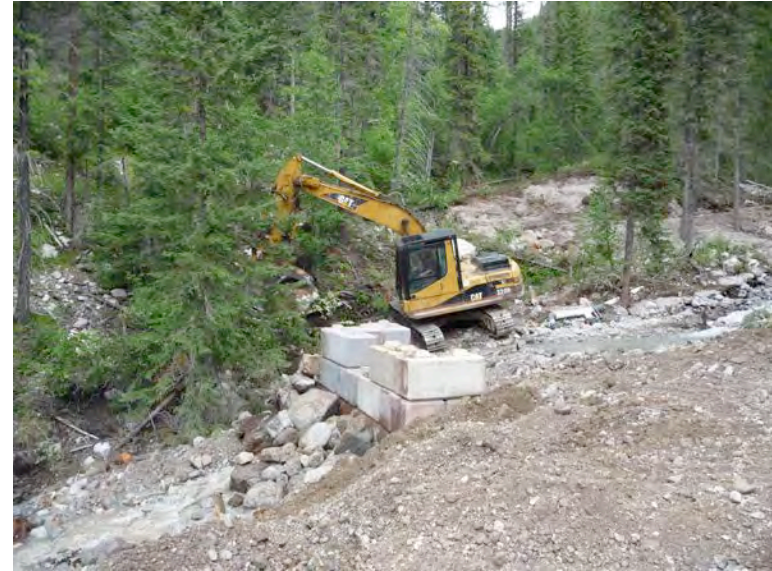
Photo 36: Reconstruction of FHSR Weir on Cold Spring Creek after 2011 event (exact date of photo unknown) (photo from RDEK)
