BC Ministry of Forests, Lands, and Natural Resource Operations and Rural Development

POST-WILDFIRE NATURAL HAZARDS RISK ANALYSIS BILL NYE FIRE (N11629)

March 2, 2022

Report Number: 21.510.01.04.03 Distribution: MFLNRO – 1 copy SNT Geotechnical Ltd. – 1 copy Sitkum Consulting Ltd - 1 copy

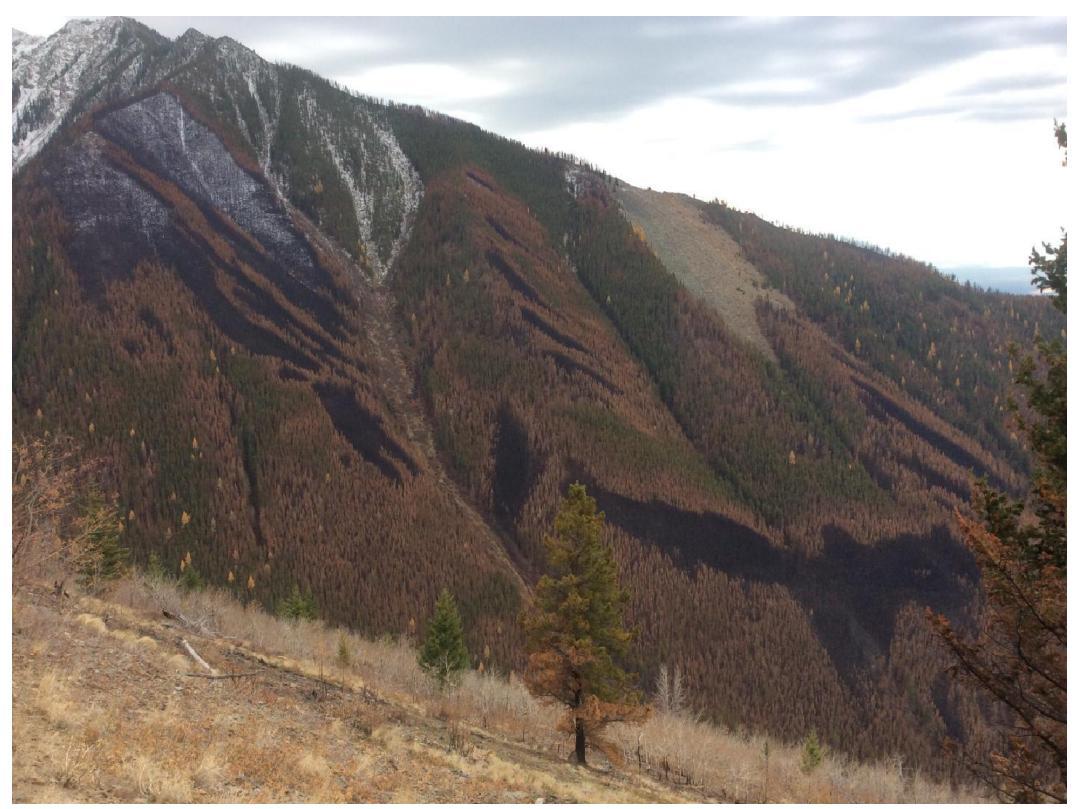
Photo 5. View looking north of high and moderate burn severity areas located in the mid-Tracy Creek drainage.

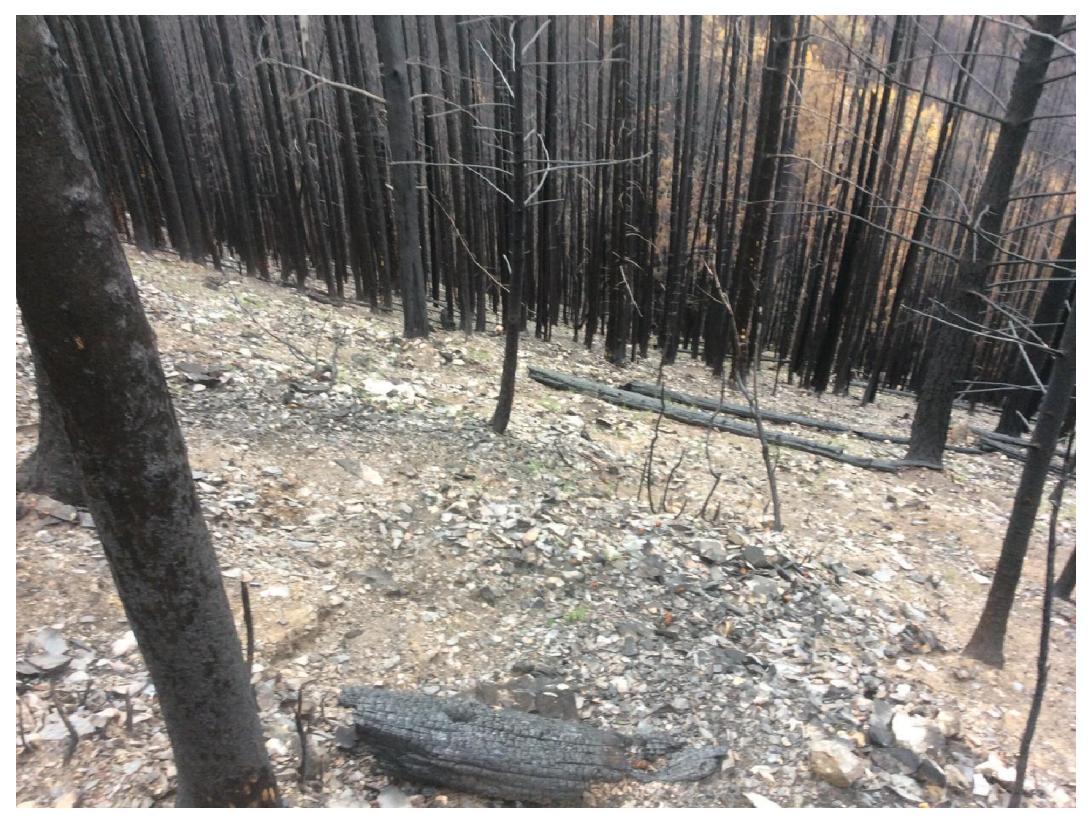
Photo 6. View looking down slope into a high burn severity area

located in the Lewis Tributary-2 drainage.

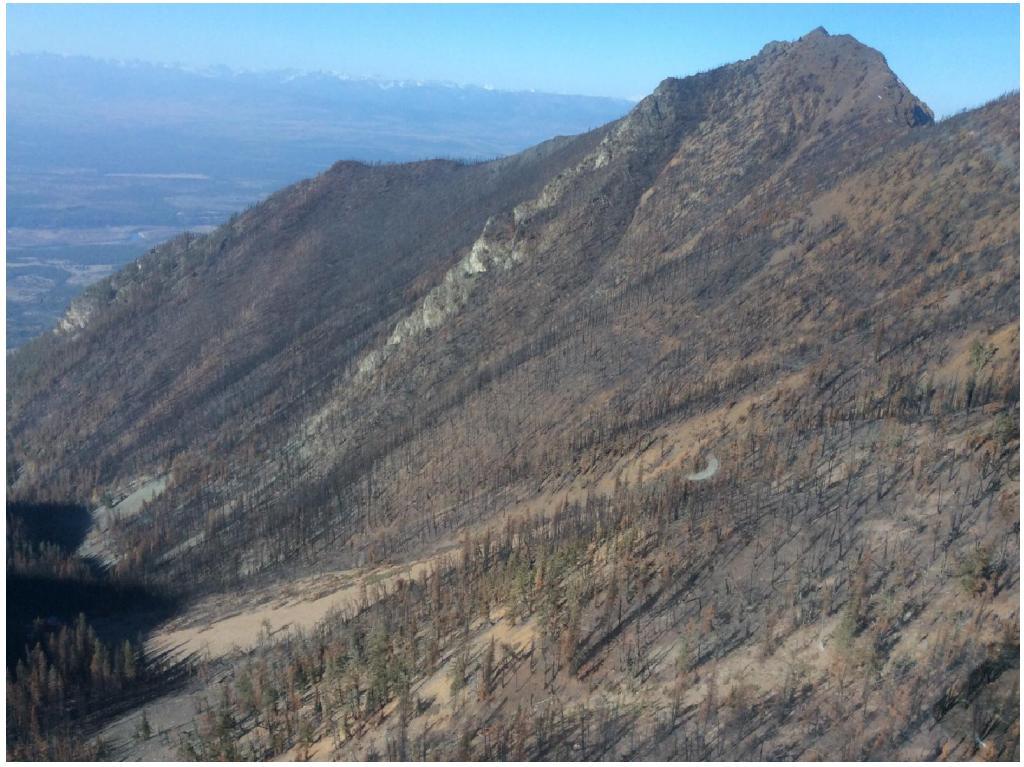
Photo 7. High burn severity area located in the lower Herbert Creek drainage.

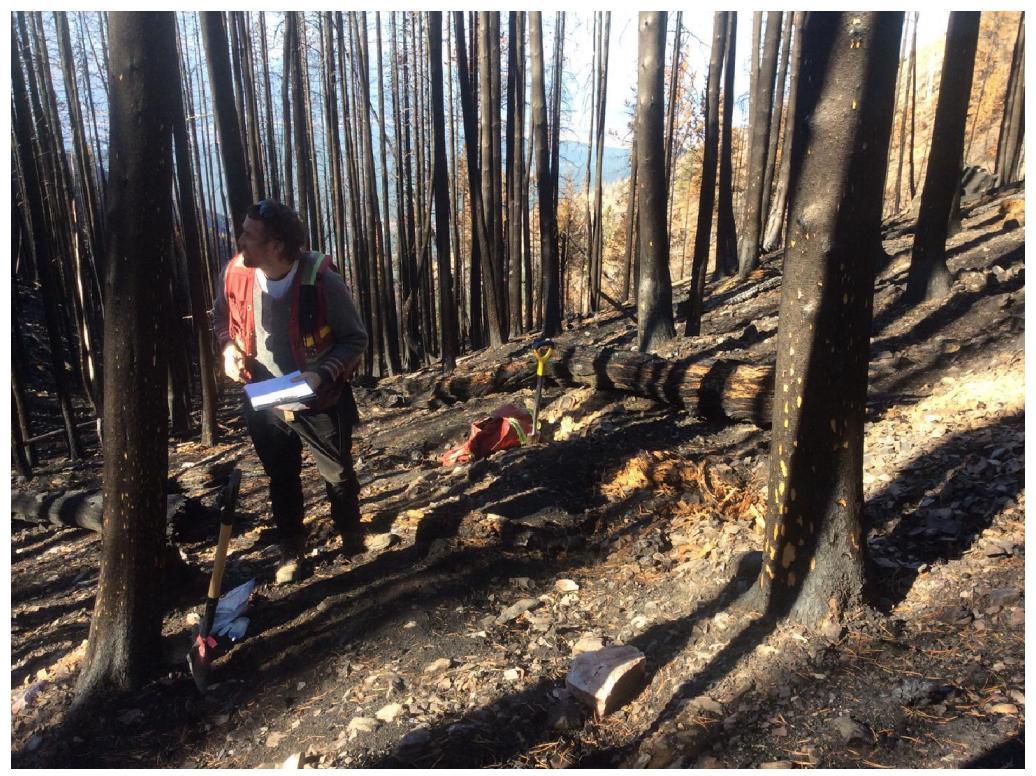
Photo 8. High burn severity area located in the upper Tracy Creek drainage near the mine site.

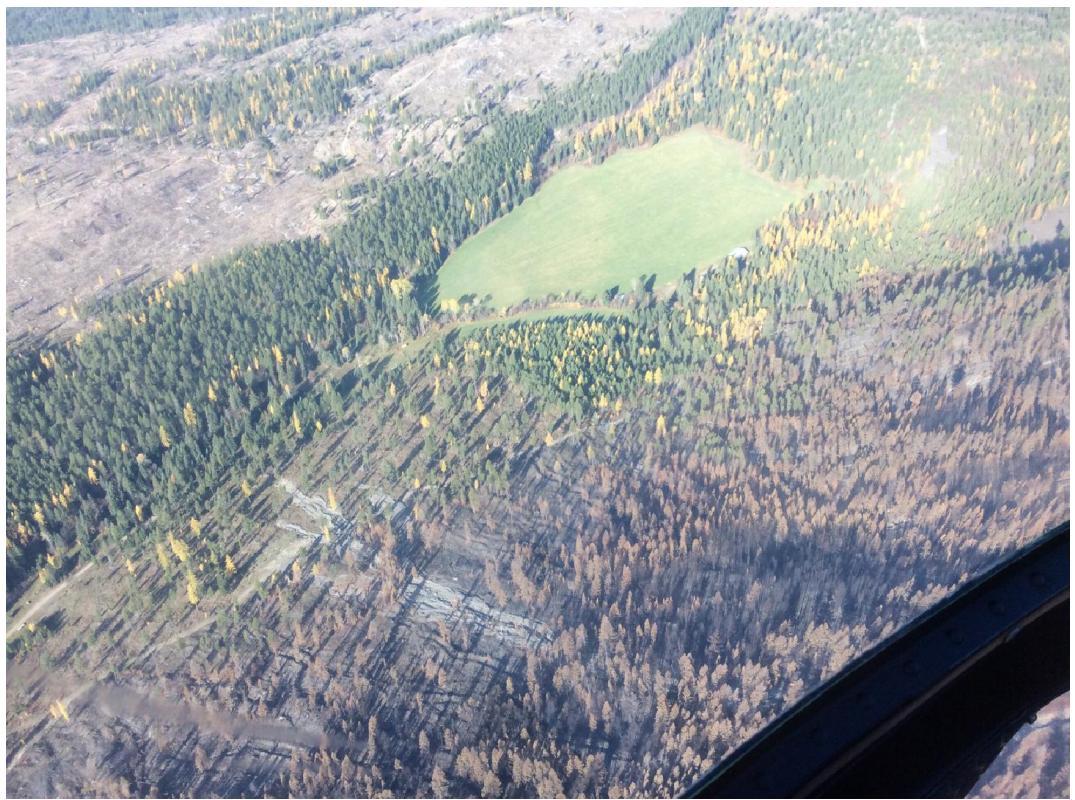
The post wildfire debris flow events likely occurred following two significant rainstorm events based on weather records (Env. Canada – Cranbrook) that indicated 29.2 mm and 21.4 mm of precipitation on August 8 and 17, 2021 respectively.

Photo 9. Helicopter overview of a recent post-wildfire debris flow located in the Herbert Tributary 2 drainage and south of House 5.

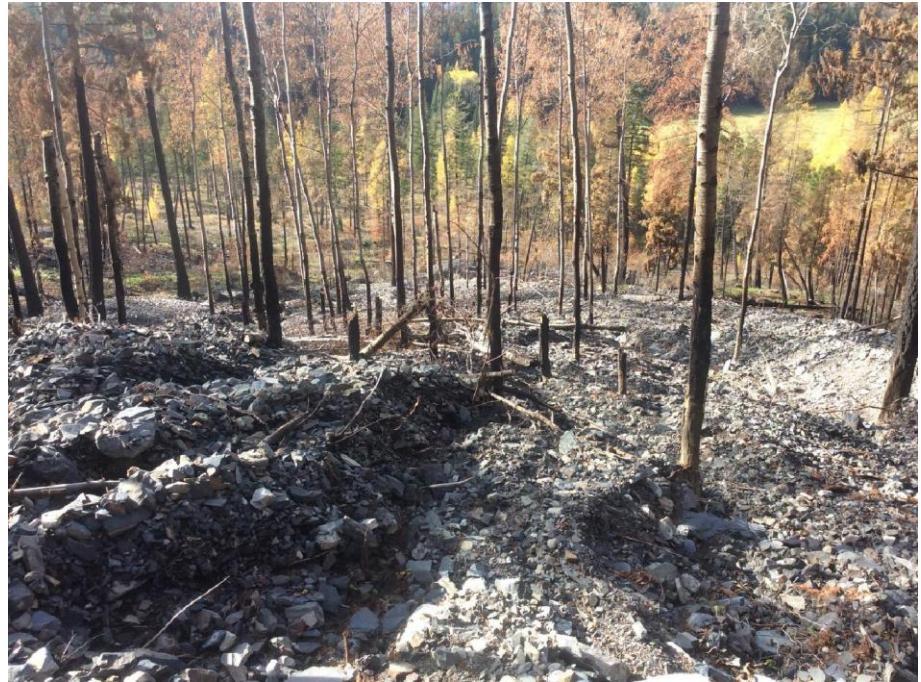
Photo 10. Recent post-wildfire debris flow located in the Herbert Tributary 1 drainage which reached the valley bottom upslope of property near House 5.

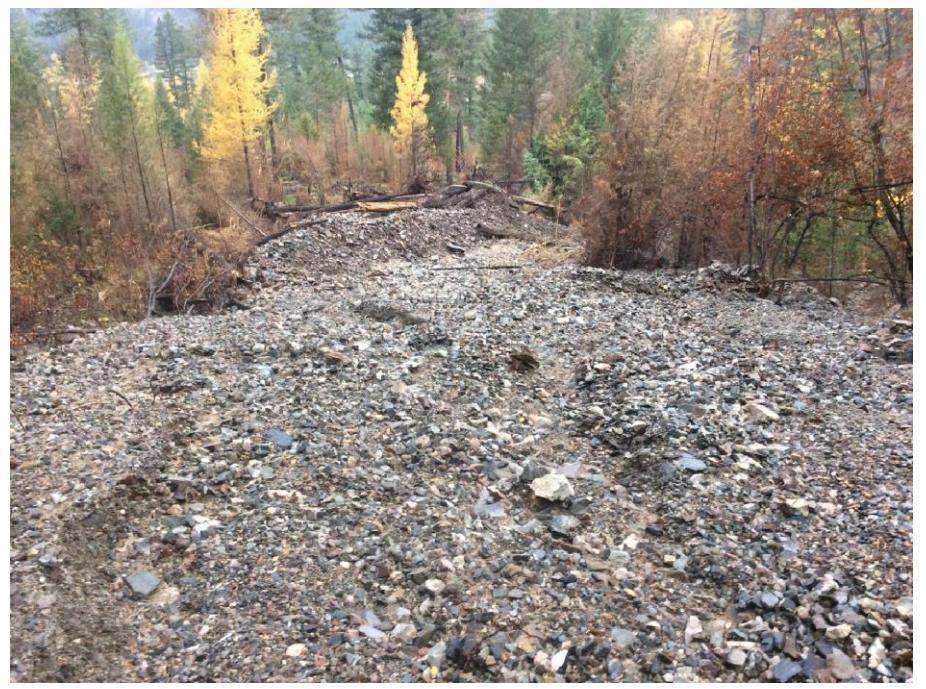
Photo 11. View looking downslope of a post-wildfire debris flow located in the Lewis Tributary 2 drainage which reached the Lewis Creek FSR.

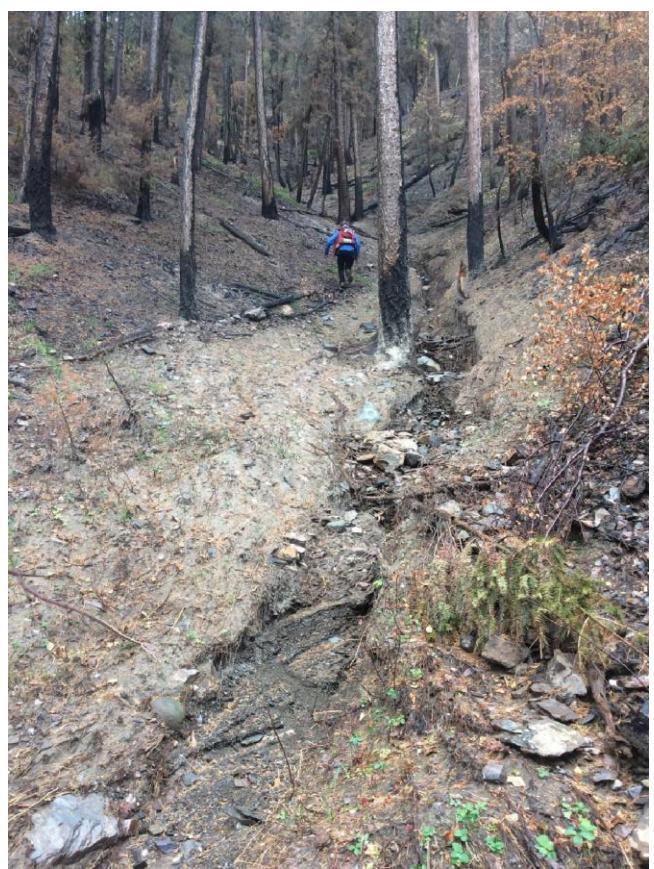
Photo 12. View looking upslope at a post-wildfire debris flow confined in a gully located in the Lewis Tributary 2 drainage; the landslide reached the Lewis Creek FSR.

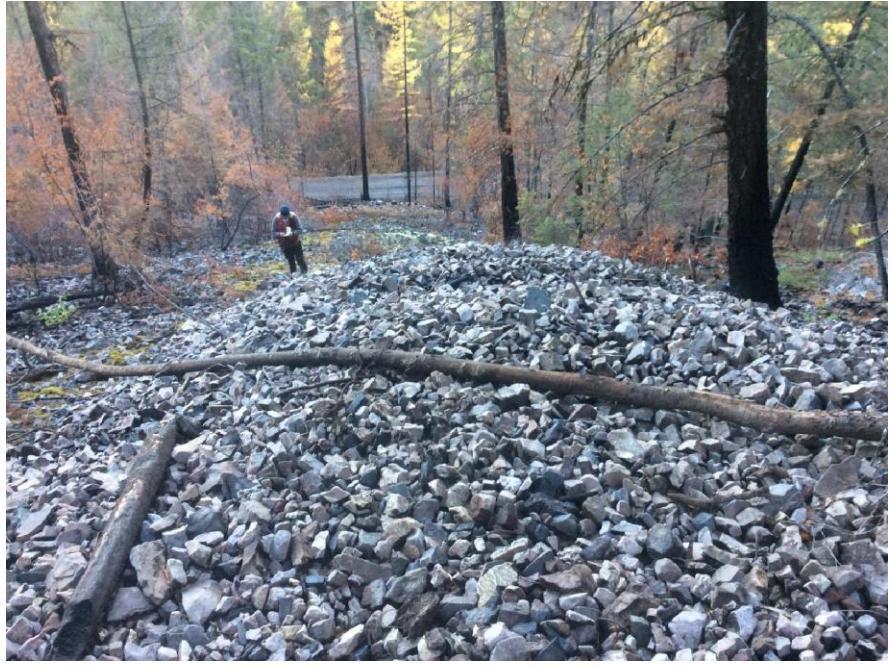
Photo 13. View looking downslope at a post-wildfire debris flow located in the Lewis West 2 drainage located upslope of House 1. The landslide terminated just above the Lewis Creek FSR.

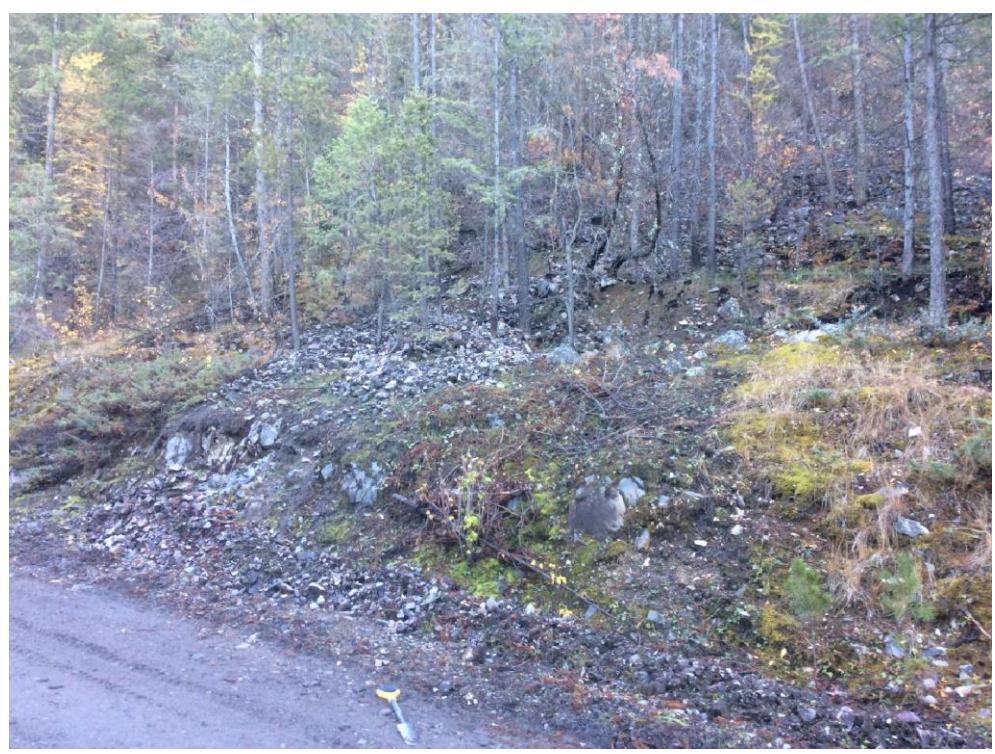
Photo 14. View from the Lewis Creek FSR at a post-wildfire debris flow located in the Lewis West 2 drainage located upslope of House 1.

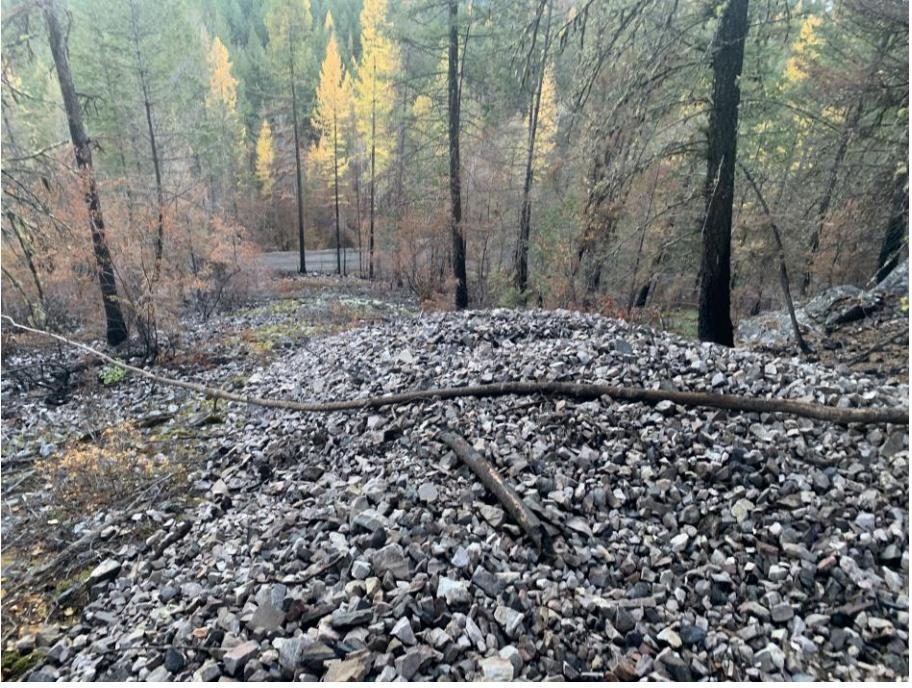
the debris flows terminated at the upslope ditch line of the Lewis Creek FSR and on talus slopes above the Lewis Creek FSR (refer to Photo 15).

Lewis Creek FSR, situated between the property and steeper segment of the face unit, would likely create a barrier where debris flow deposition would occur; however, potential nuisance flooding could still reach the house.

Photo 15. Debris flow deposition above Lewis Creek FSR.

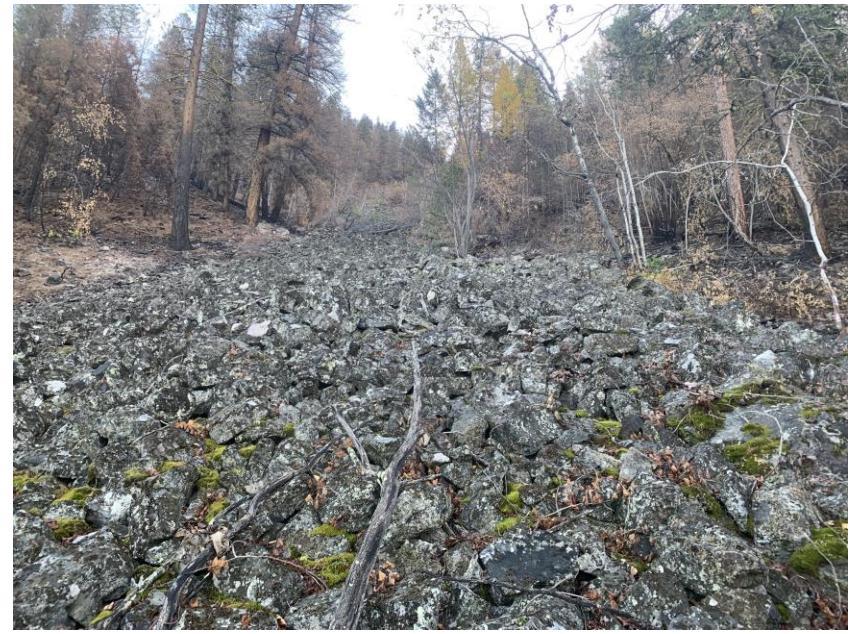
Photo 16. Talus located along base of draw within the Lewis Tributary 1 drainage.

As per Table 3, Lewis Tributary 1 drainage has a high post-wildfire incremental debris flow hazard.

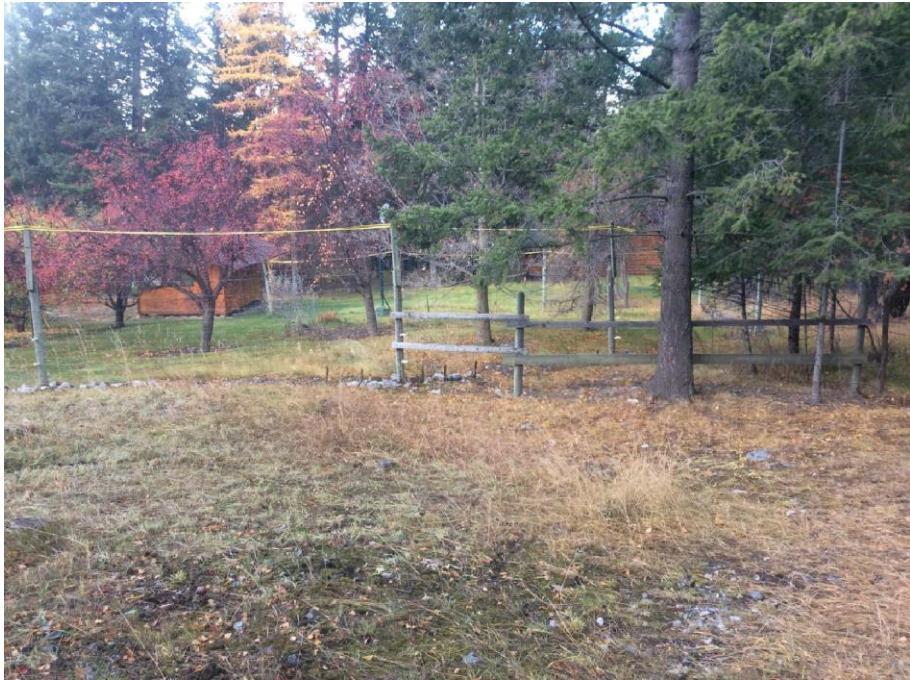
Photo 17. View looking west at House 3 situated in the middle of the Tracy Creek fan.

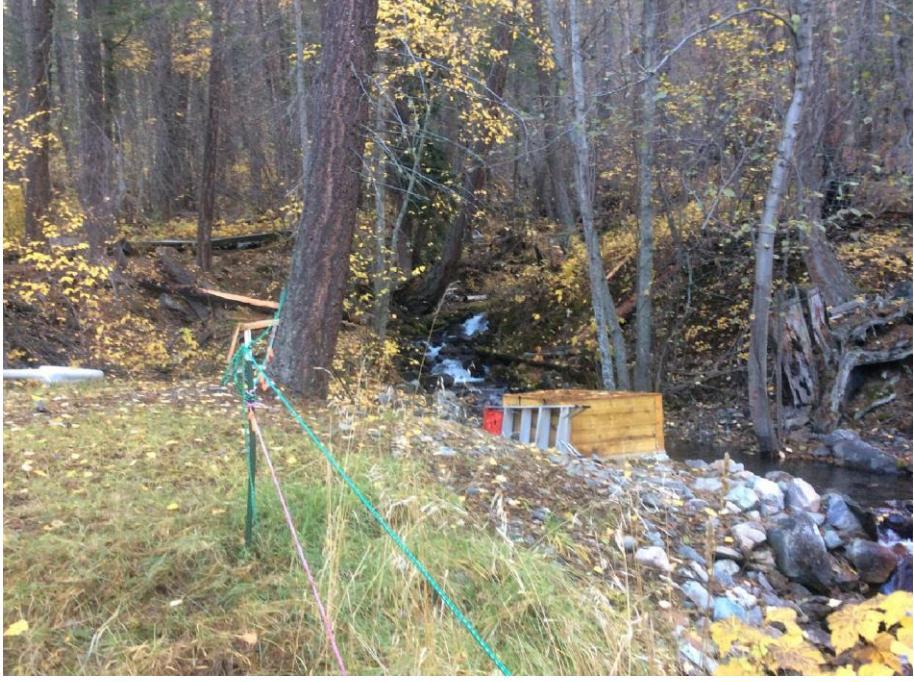
Photo 18. View looking upstream at Tracy Creek and the location of the POD (irrigation) situated near the apex of the Tracy Creek fan.

contained within a gully throughout the middle to lower reaches of the drainage; however, the creek has variable confinement across the fan and avulsion is possible in the event of a debris flow or flood. The creek channel was modified to accommodate the water intake for the POD, resulting in a shallow confinement of the creek channel, which could potentially result in water and debris spilling out of the gully in the event of a debris flow. Furthermore, there is an access trail which leads from the water intake and down towards House 3 (Photo 18).

In the event of a significant debris flow event there is a high likelihood of a direct impact and damages to the POD (irrigation) and related infrastructure. In addition, there is a moderate to high likelihood that water and debris will be forced out of the gulley at the location of the water intake due to the shallow confinement.

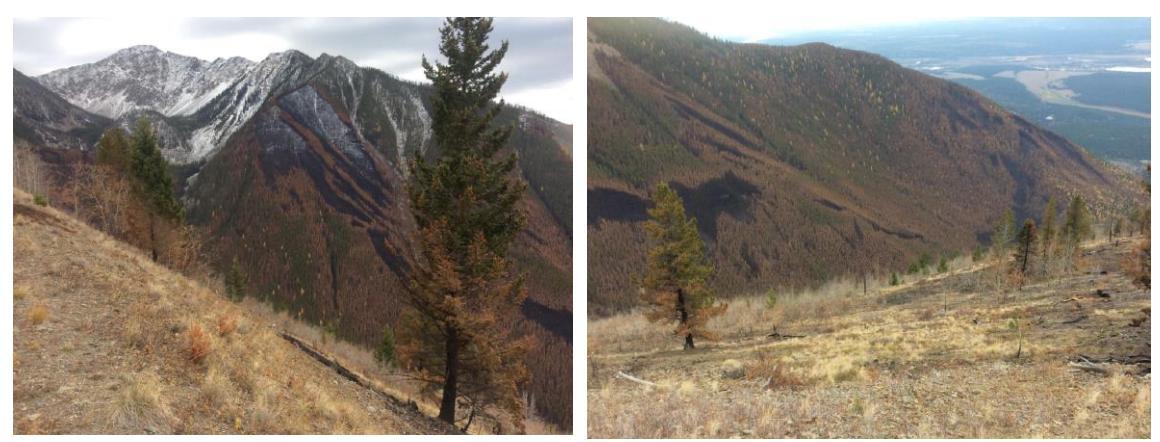
Photos 19 and 20. View looking south at the south side of the lower area of Tracy Creek drainage upper and lower with mostly moderate and high vegetation burn severity.

Taking into consideration the post-wildfire conditions within the Tracy Creek drainage as well as the upslope relief within the gully system, the likelihood of incremental post wildfire landslides and flooding within the Tracy Creek drainage is estimated as moderate (Table 3).

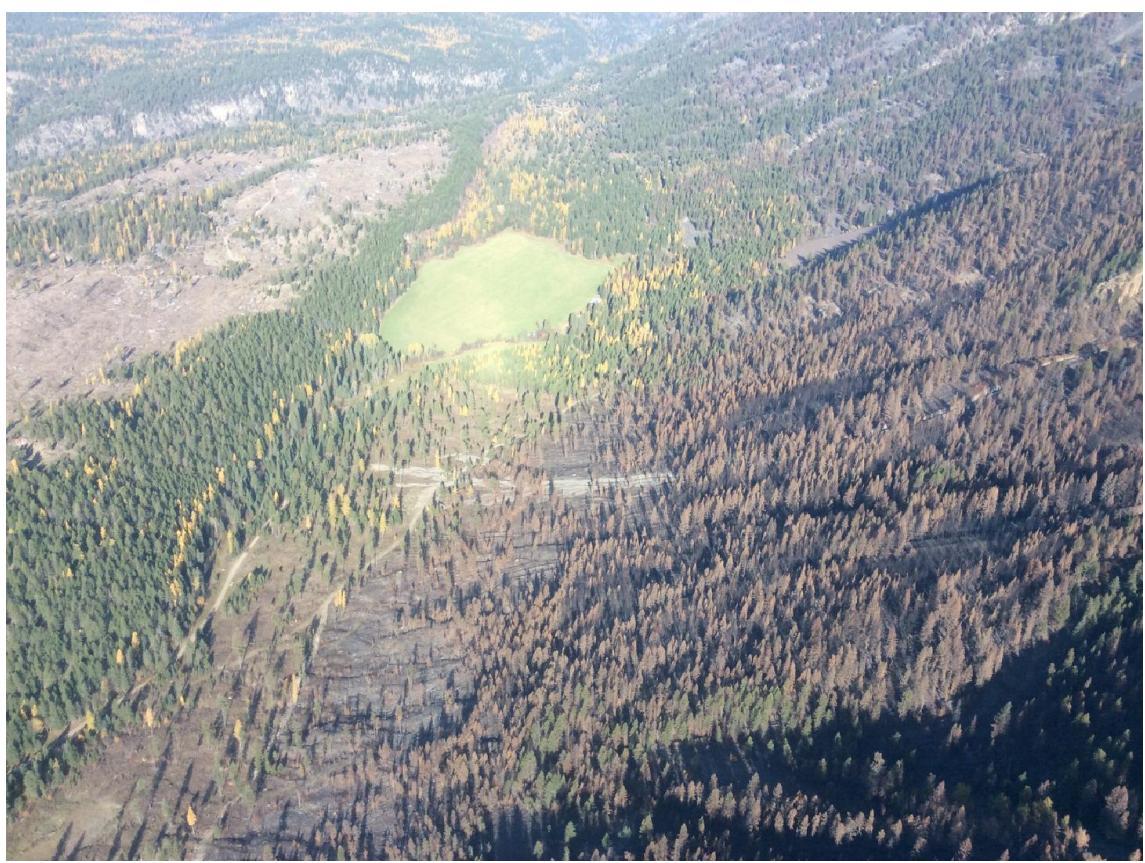
Photo 21. View looking north at House 5 and private property situated in the Herbert Creek watershed. Note the recent post-wildfire debris flows located just south of the property.

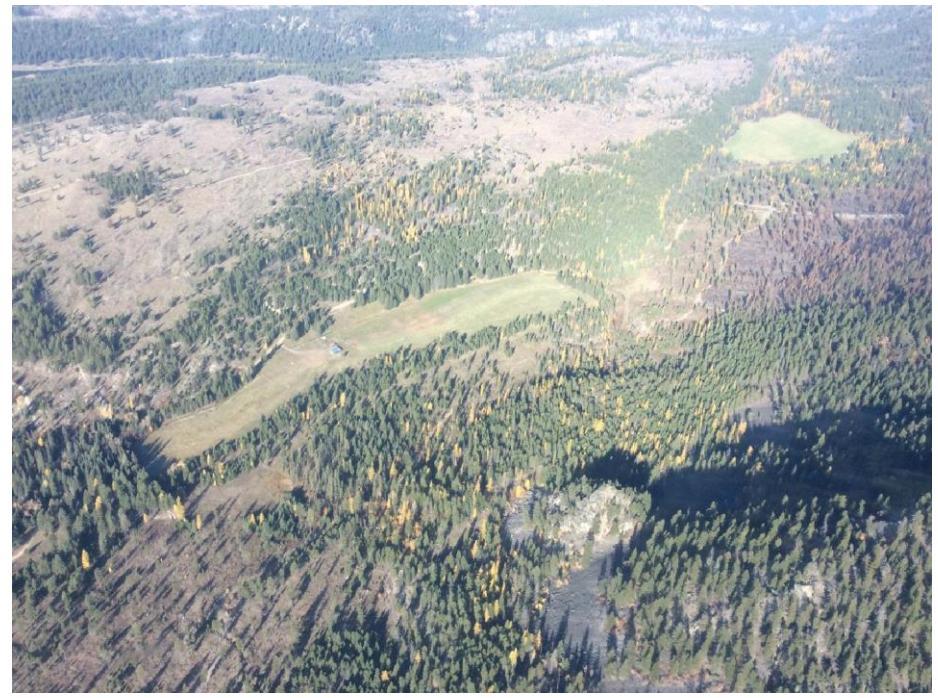
Photo 22. View looking northwest at House 6 and private property situated in the Herbert Creek watershed south of the Bill Nye Fire which can be seen in the upper right corner of the photo.

In the event of a significant debris flow in any of Herbert Creek or the Herbert Tributaries the debris would likely deposit across the respective fans; however, turbid flood flow and other flood related hazards such as bank erosion and channel avulsion within Hebert Creek could potentially affect House 6. While there is a high likelihood of debris flows and increases in runoff in each of the affected Herbert drainages except for Herbert Tributary 3, the potential for hazardous flood process to occur in Herbert Creek downstream of all these drainages is tempered by the extent of gentle gradient fans separating the upslope streams from the main valley bottom creek where much runoff is likely to disperse into subsurface flow. As a result, there is a moderate likelihood for flood related hazards to impact the vicinity of House 6 resulting in a MODERATE TO HIGH PARTIAL RISK (flood related hazards) to House 6.

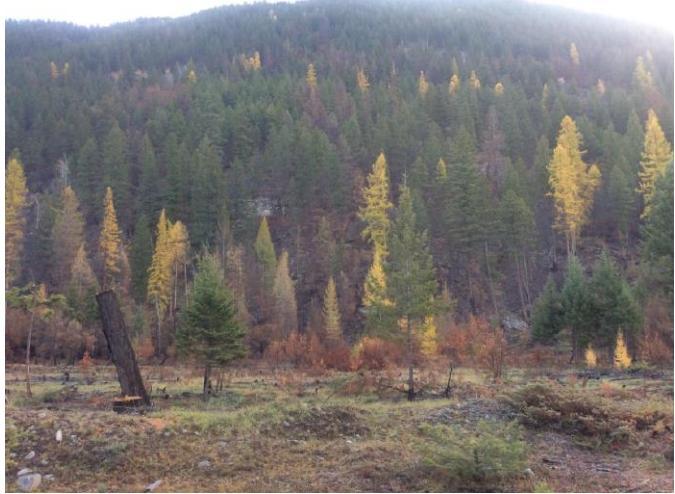
Photo 23. View looking east from the Lazy Lake Road at the Tracy North – Lewis Tributary 1 Face showing moderate to low burn severity areas.

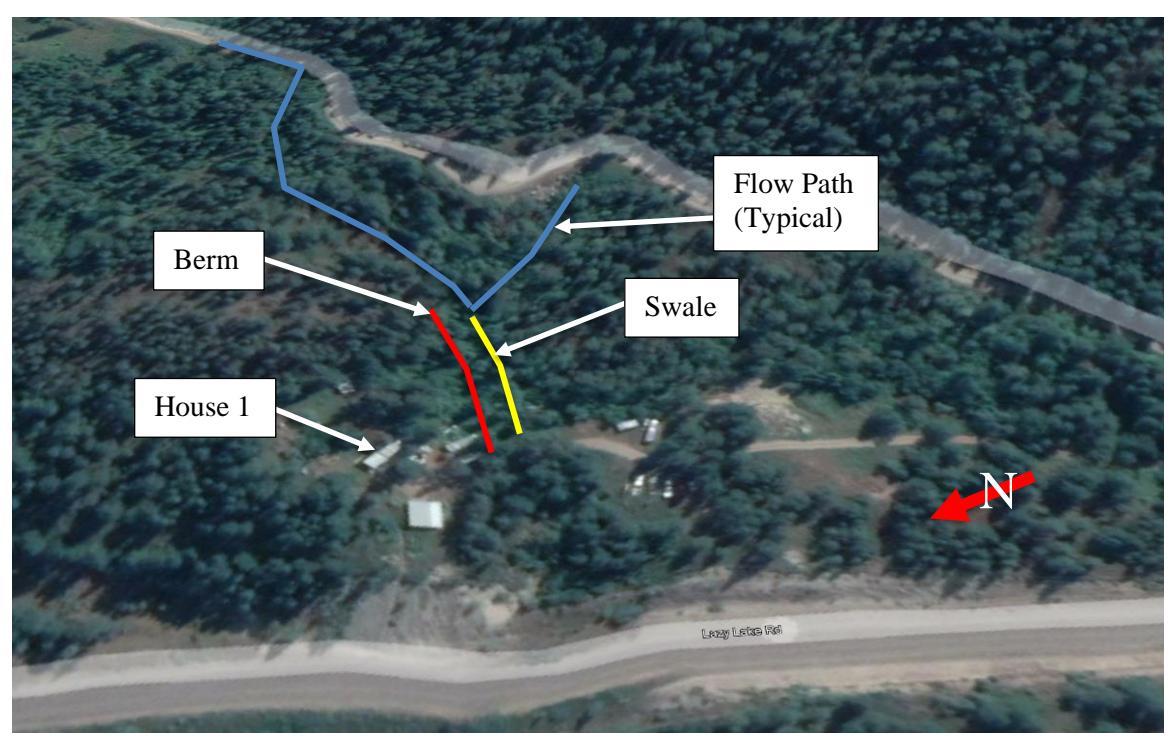
Photo 24. Proposed House 1 berm and swale locations (Google, 2018)

Recommendation 5: The construction of a deflection berm and/or swale that would be designed by a qualified professional, should be considered above House 1. The berm/swale could extend from the bedrock outcrop on the north side of the natural bedrock-controlled gully to the northeast edge of the bench that House 1 is located (Photo 24).

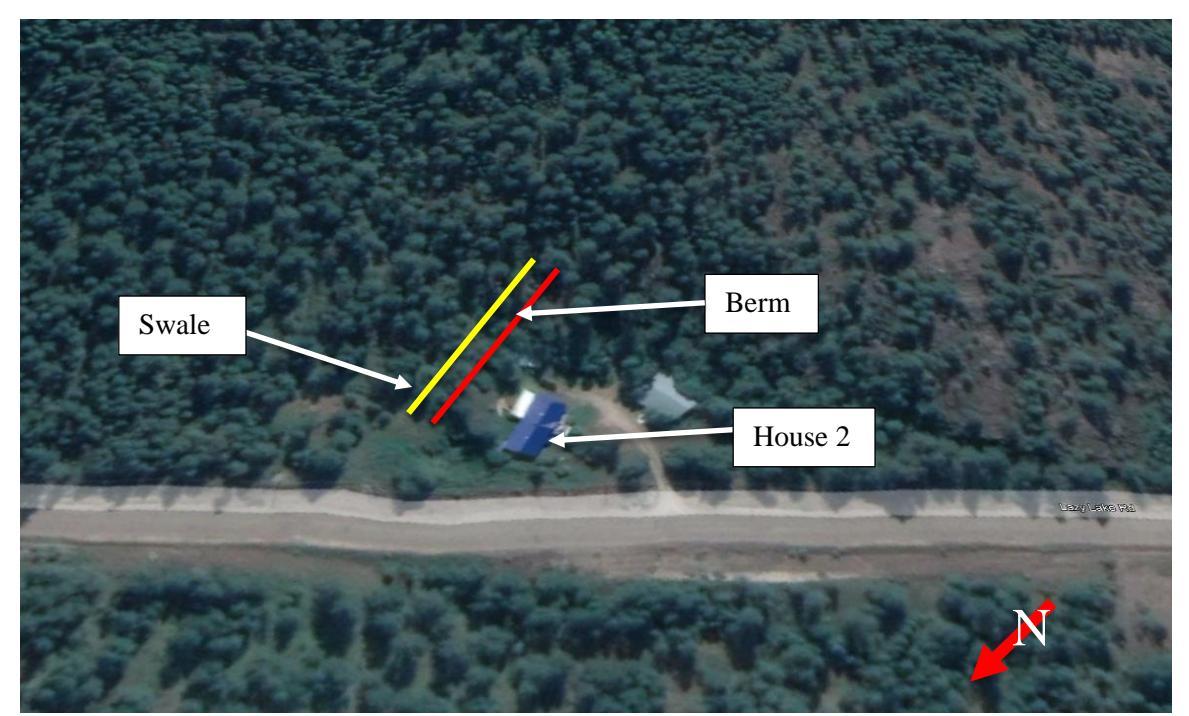
Photo 25. Proposed House 2 berm and swale locations (Google, 2018)

Recommendation 7: The construction of a deflection berm and/or swale, that would be designed by a qualified professional, should be considered up slope of House 2 extending from the rock bluffs to the downslope extent of House 2 (Photo 25).
