NHC Ref. No. 3005607

Re: **Macaulay Creek May 31 2020 Turbidity Event**
June 1st Overflight Observations

This report provides a brief assessment of the increased turbidity witnessed at Lake Baptiste during the 2020 May 31st flood events.

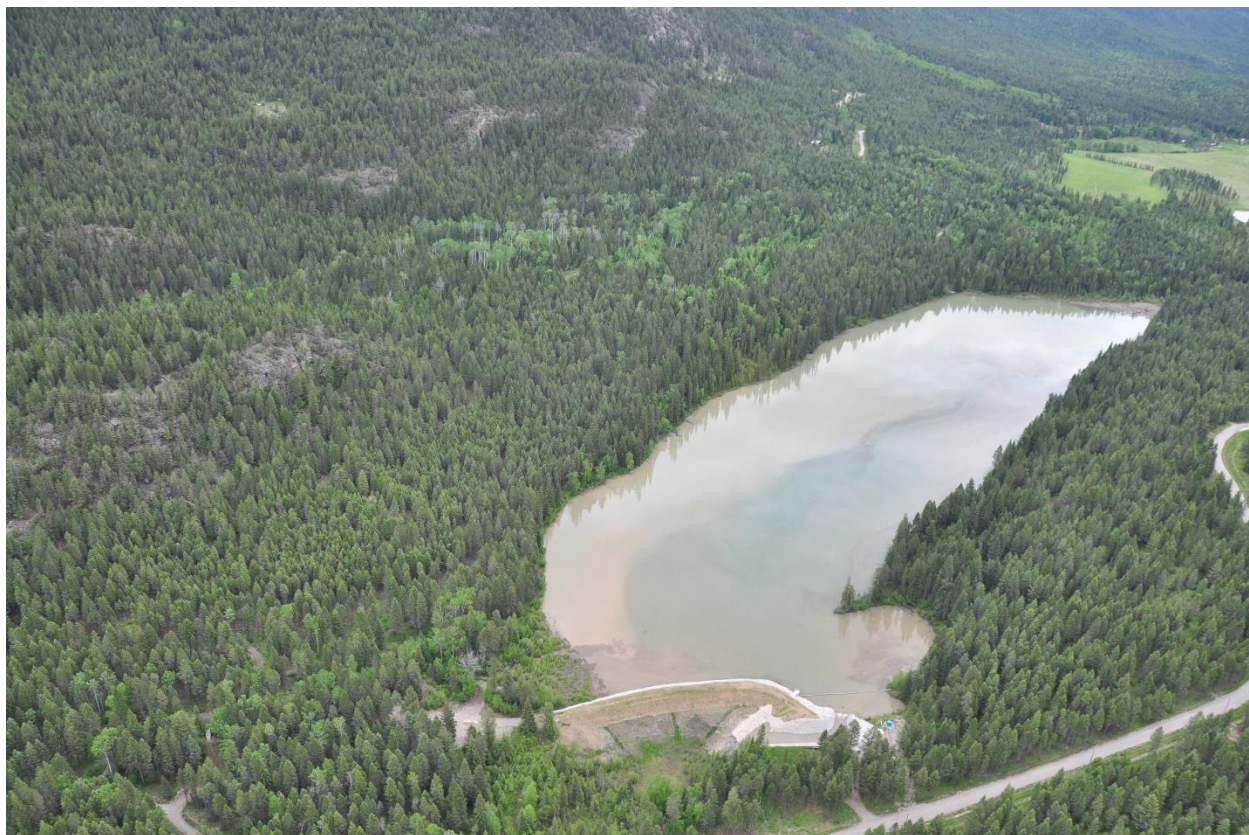
Turbidity increased in the reservoir and at the reservoir intake during the flood events (**Photo 1**), leading to a one month long boil-water notice issued to the residents of Edgewater by the Regional District of the East Kootenay (RDEK). The reservoir was visibly more turbid along its east side and most turbid at the north east corner where water enters from the Macaulay Creek diversion. There are no additional

Photo 1 **Turbidity at the Lake Baptiste Water Intake on 2020 June 1. The reservoir was more turbid on the east (left in this photograph) side, and most turbid at the north east corner, where water enters from the Macaulay Creek diversion.**

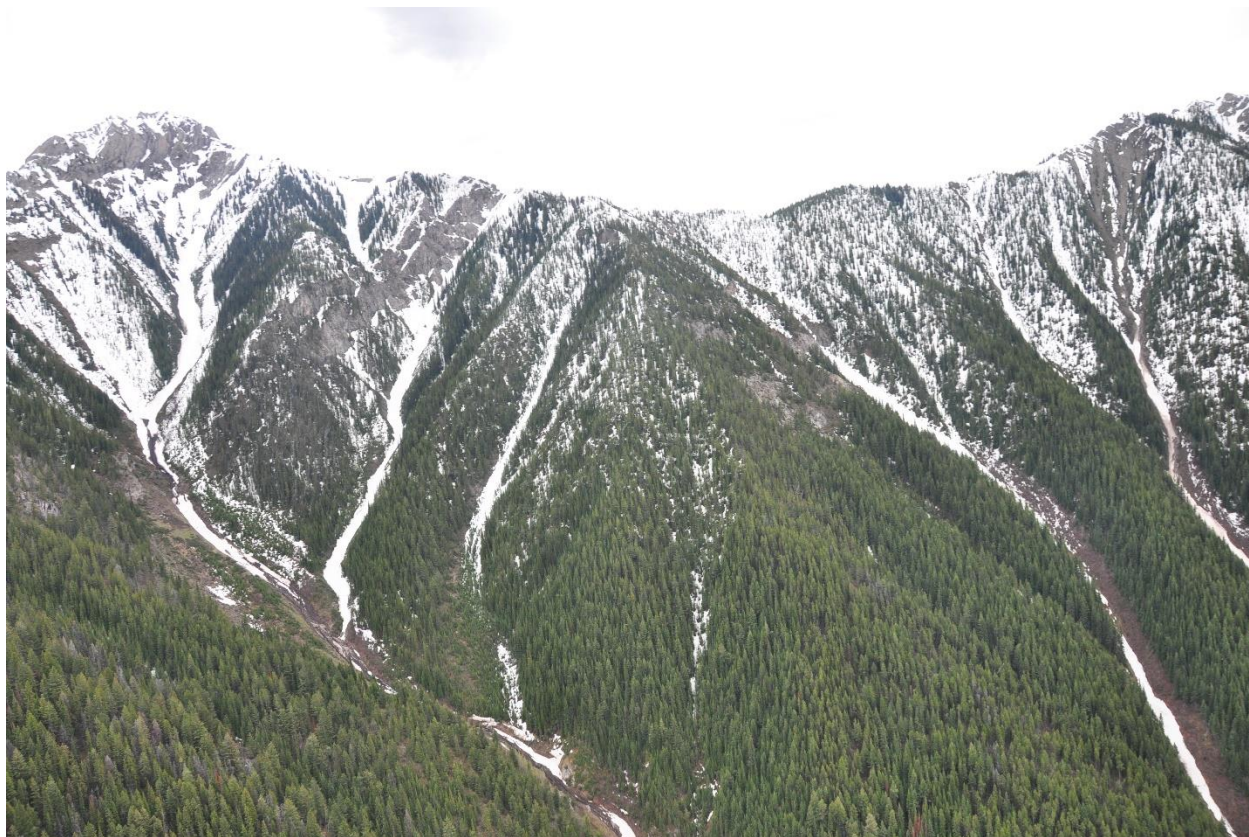
The aerial survey covered the entire watershed of Macaulay Creek. There were some small mass wasting events on the hillslopes in the upper watershed (**Photo 2**) - mostly associated with spring avalanche cycles - but none of these were coupled to a stream channel. Localized erosion (**Photo 3**) and deposition (**Photo 4**) was observed along stream channels in between the upper hillslopes and the diversion intake, but there was no evidence of the channel being affected by large mass wasting events such as debris flows or debris floods. We therefore attribute the source of reservoir turbidity to sediment entrained from the channel banks and bed in the Macaulay Creek stream network as water levels rose during the flood event.

Photo 2 Hillslopes in the upper watershed of Macaulay Creek. A small mass wasting event can be seen in the avalanche gully on the right side of the frame, but this was not coupled to the stream channel network and we therefore do not consider it a source of reservoir turbidity.

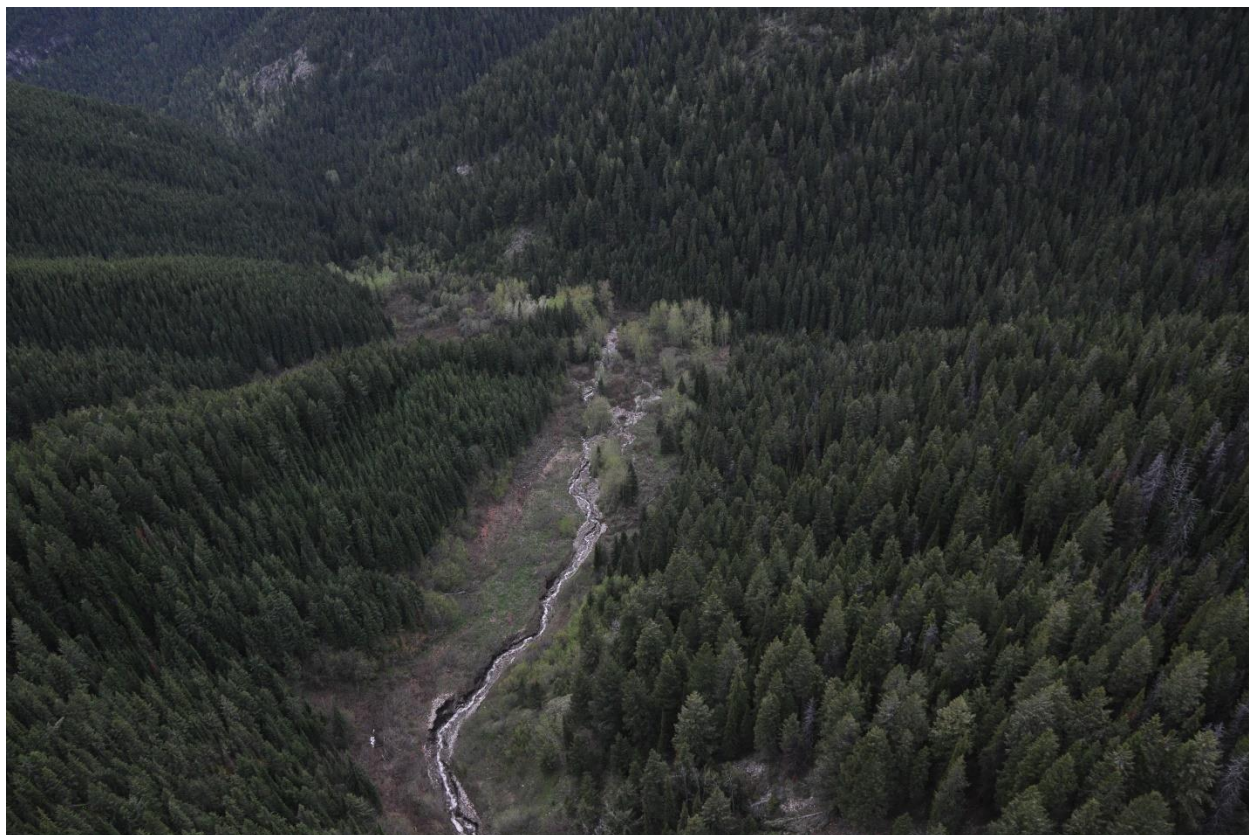
channels that enter the reservoir visible from the aerial photographs or satellite imagery. While there was likely some local erosion of the road network and its associated drainage structures surrounding the reservoir, we attribute the primary source of reservoir turbidity to Macaulay Creek.

Photo 3 Photo showing localized erosion and incision of the Macaulay Creek channel. We attribute the reservoir turbidity to sediment entrained during clearwater flooding as water levels rose along the banks of the creek during the flood event.

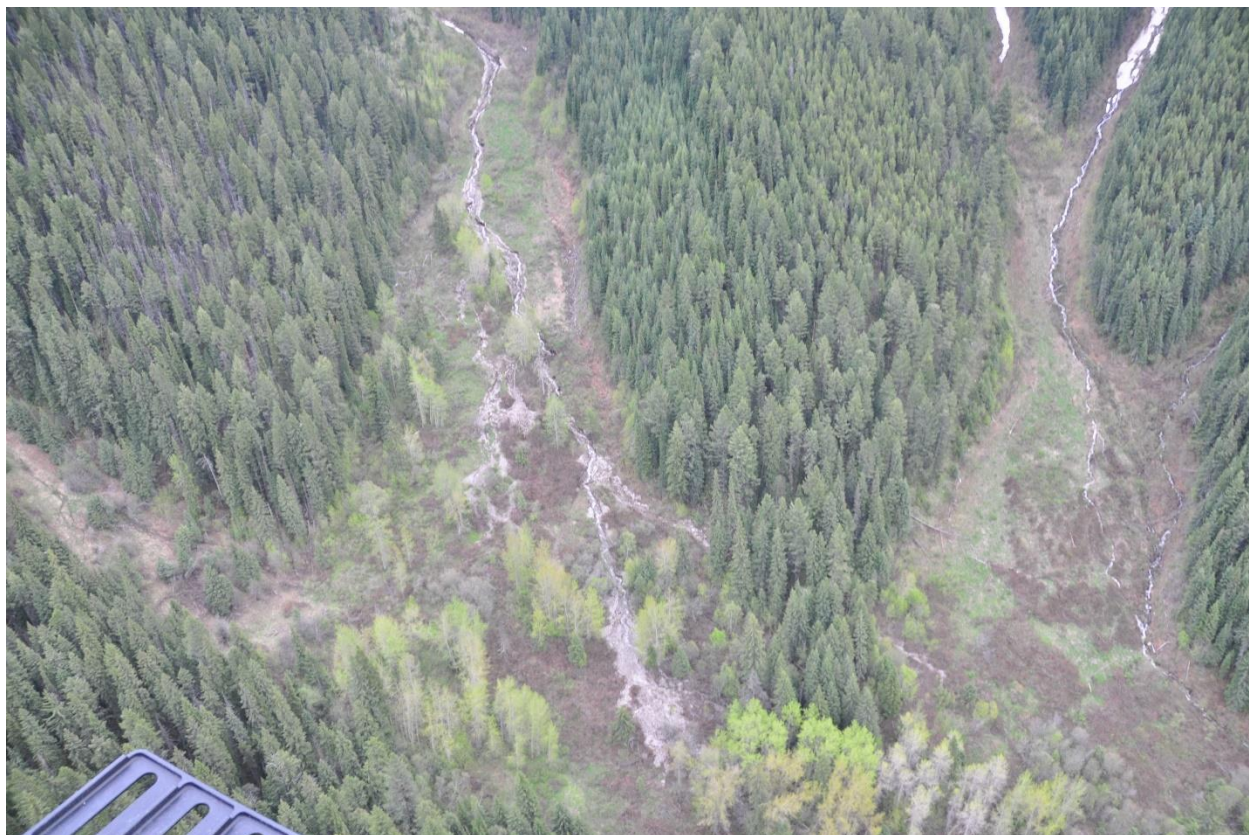
Photo 4 **Localized sediment deposition along stream channels in the Macaulay Creek Watershed. No evidence of debris flows or debris floods were observed in the watershed.**
