## WINDERMERE CREEK HYDROTECHNICAL ASSESSMENT

Regional District of East Kootenay  
19 – 24<sup>th</sup> Avenue South  
Cranbrook, BC V1C 3H8

2013 January 18  
NHC 3000128

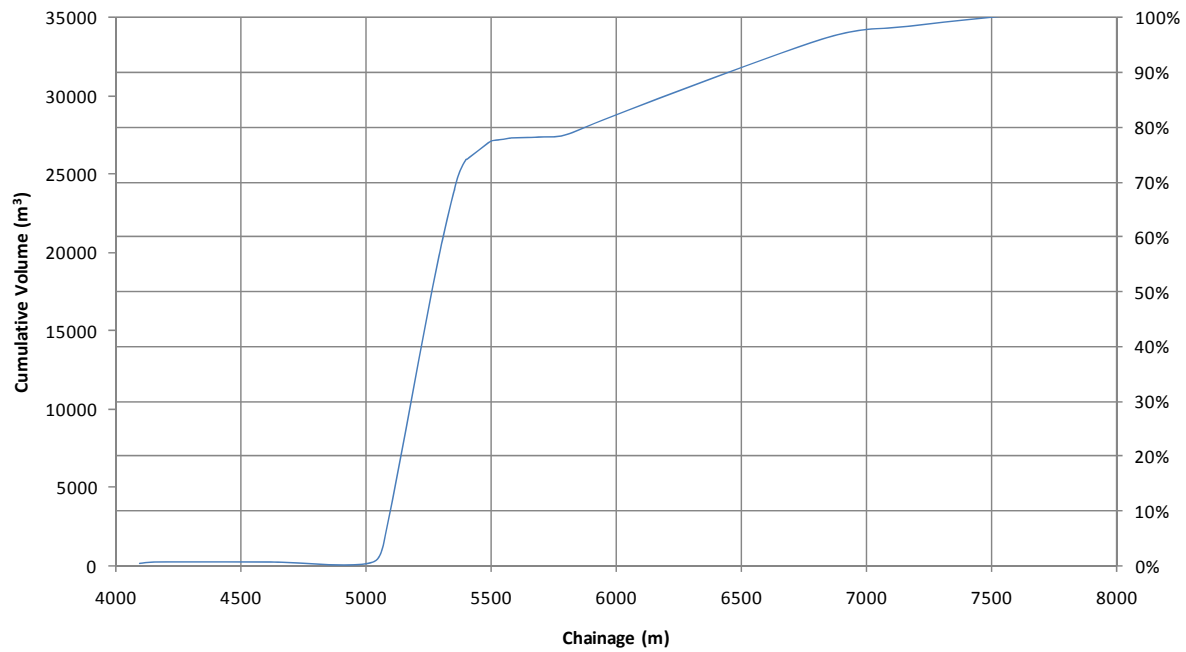
**Figure 4. Cumulative volume of sediment eroded from the channel in 2011 and 2012.**

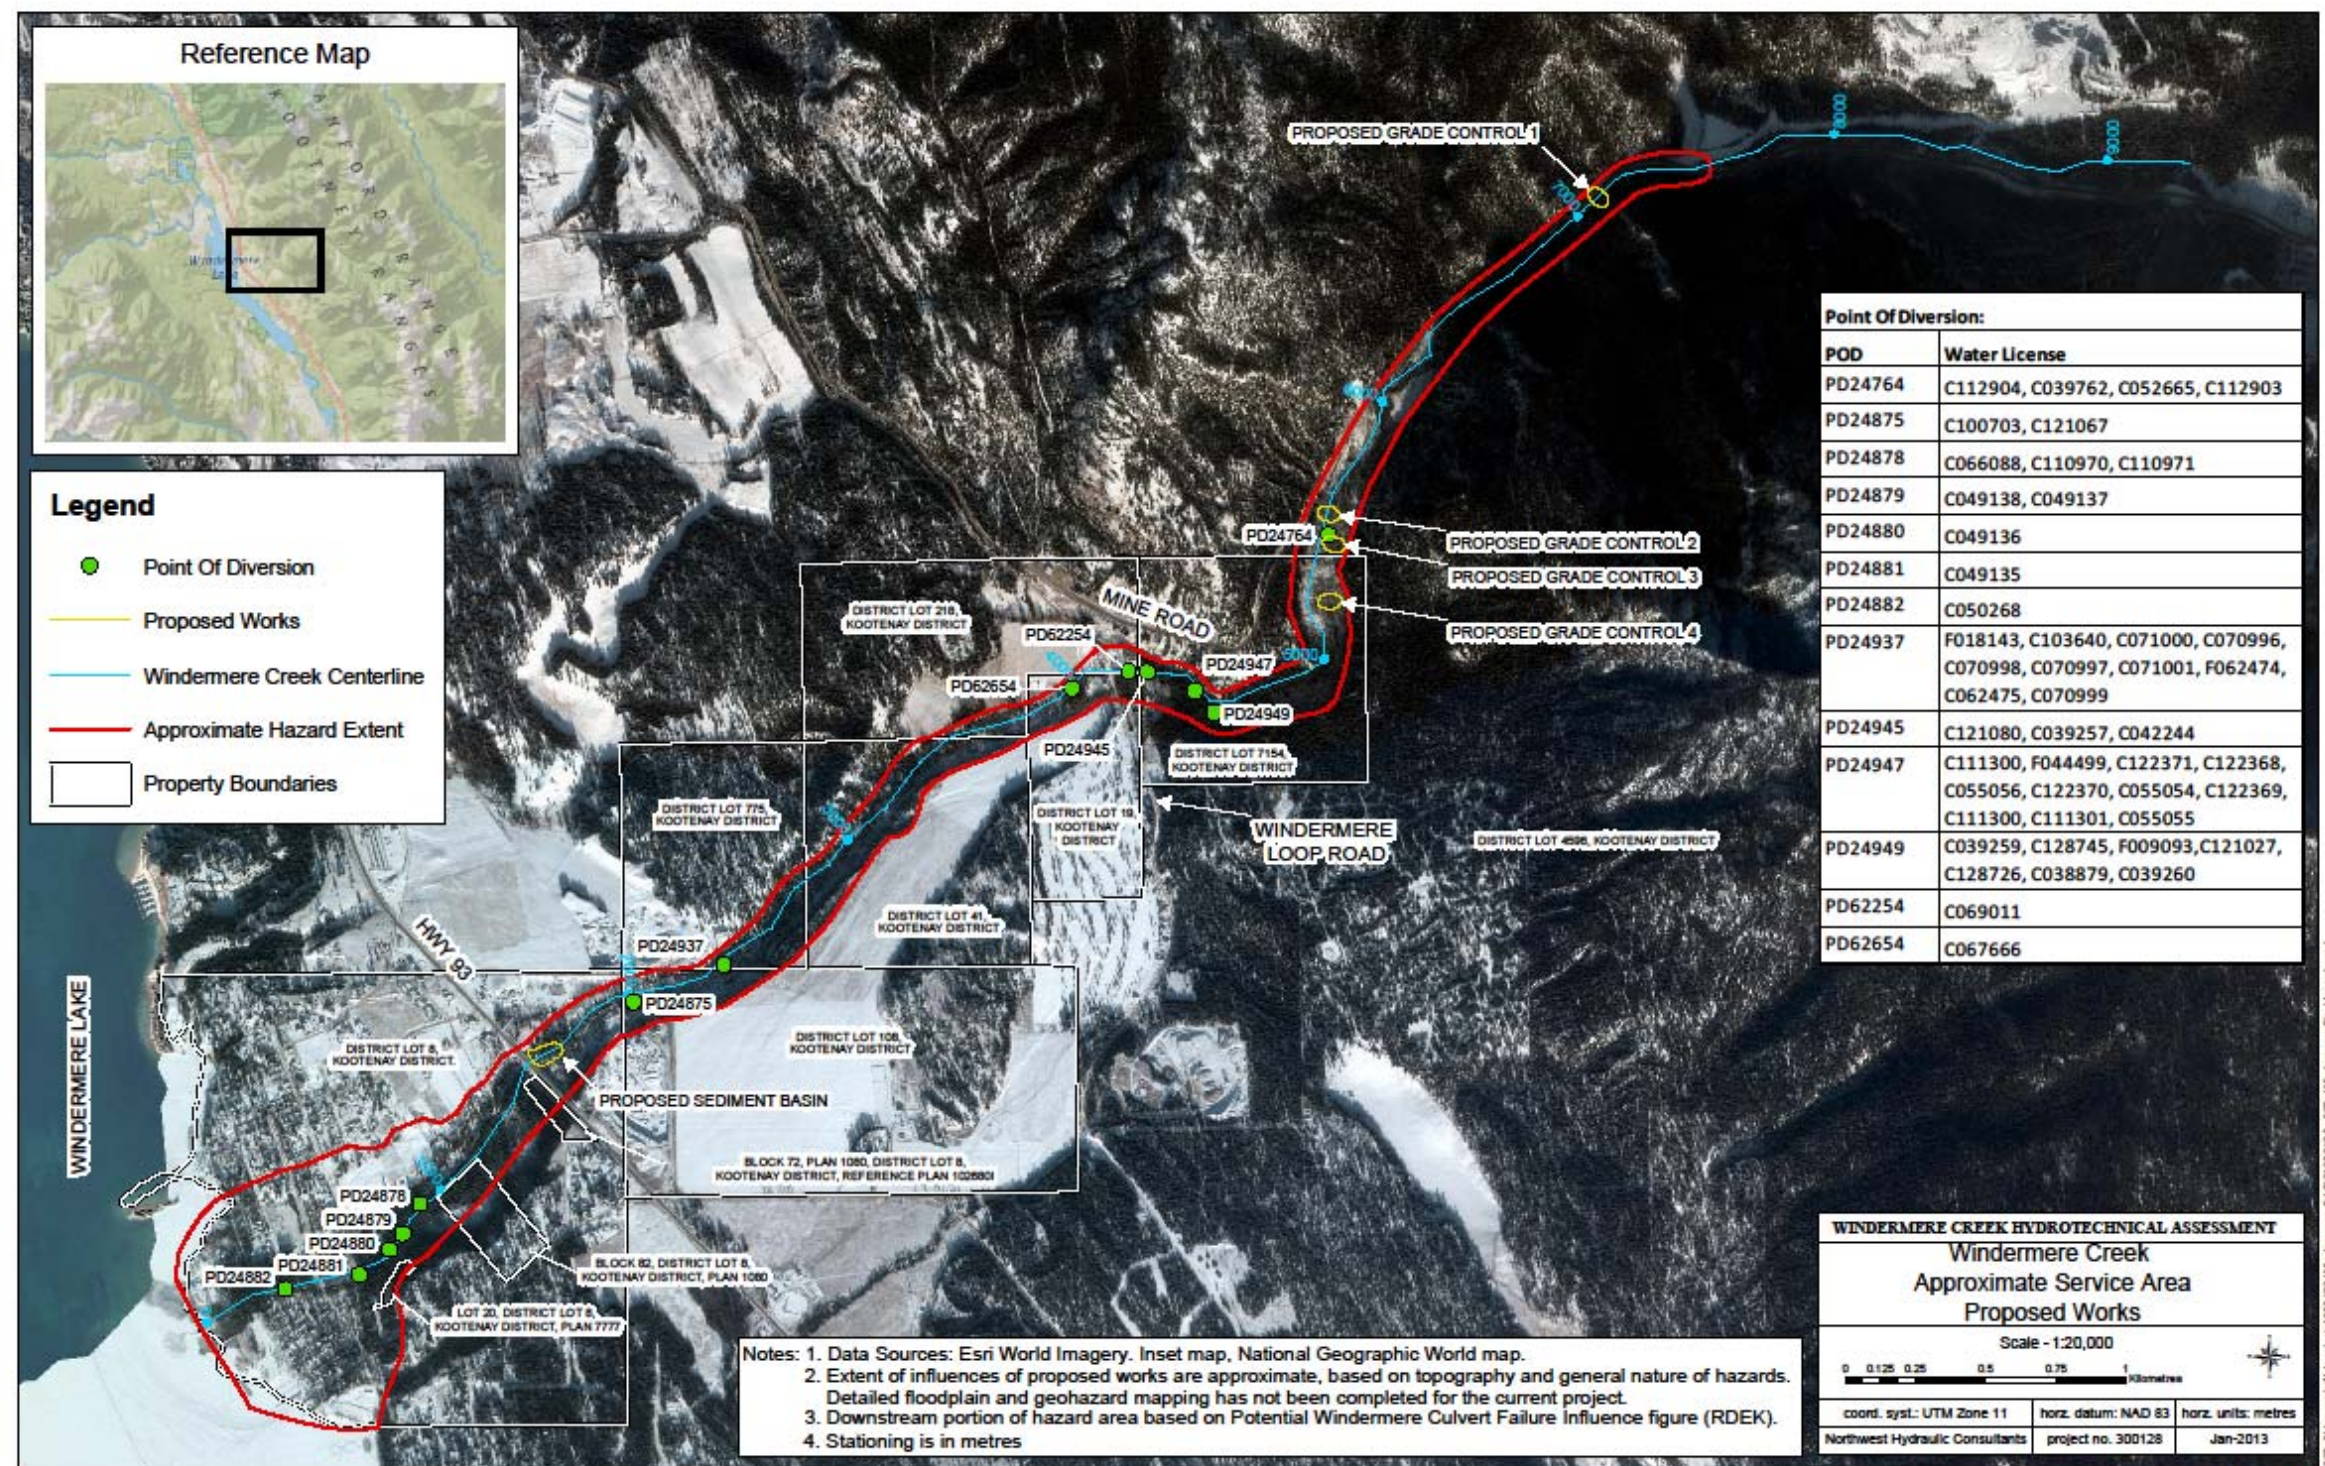
Figure 9

Figure 9. Windermere Creek, approximate service area for recommended mitigation options.

Mitigation measures should address both the channel instability in the upper reach and the ongoing deposition of sediment downstream. No one solution is able to address both of these issues. Therefore, it is recommended that a series of grade controls be constructed to maintain vertical grade of the channel in the most destabilised reach - roughly 1 km upstream of Windermere Loop Road - and a sediment trap be constructed upstream of Highway 93 to intercept and allow controlled removal of transported sediment. It is expected that the middle grade controls also be used to re-establish flow along the north side channel limiting the stress on the south channel and potentially improve habitat value. Class D cost estimates for construction of the grade controls and sediment basin are \$170,000 and \$315,000, respectively. Five-year operations and maintenance costs are estimated at \$17,000 for grade controls and \$60,000 - \$250,000 for the sediment basin.

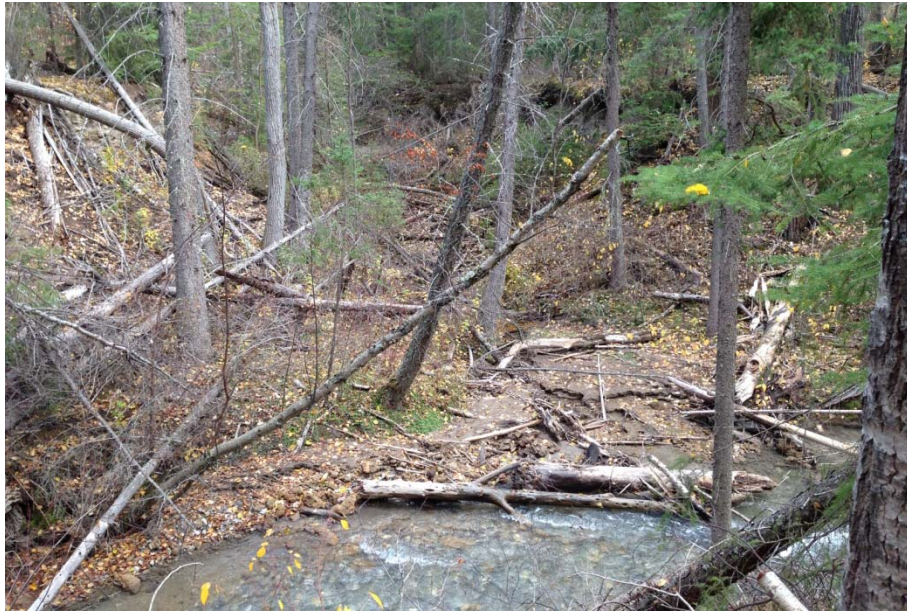
Average channel gradient in this reach is about 6%. A small tributary enters the creek just downstream of **Photo 16**, but is not expected to influence channel stability. The tributary was almost dry during the October field assessment (**Photo 17**).

**Photo 17.** Downstream view toward small tributary entering Windermere Creek on left bank, approximately 25 m downstream of north and south channel confluence, Sta. 4+970.

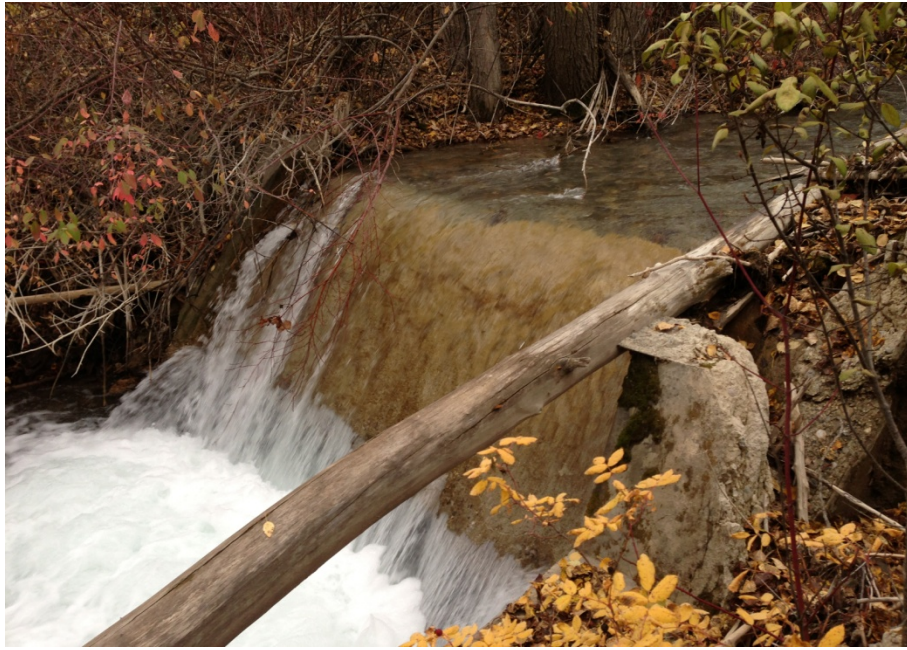
An abandoned concrete diversion weir approximately 2 m high is located approximately 40 m upstream of the WLR culvert. The channel locally aggraded upstream of the structure (**Photo 21**). No evidence of outflanking or undermining of the structure was detected.

**Photo 21.** Concrete diversion weir upstream of Windermere Loop Road culvert, Sta. 4+190.

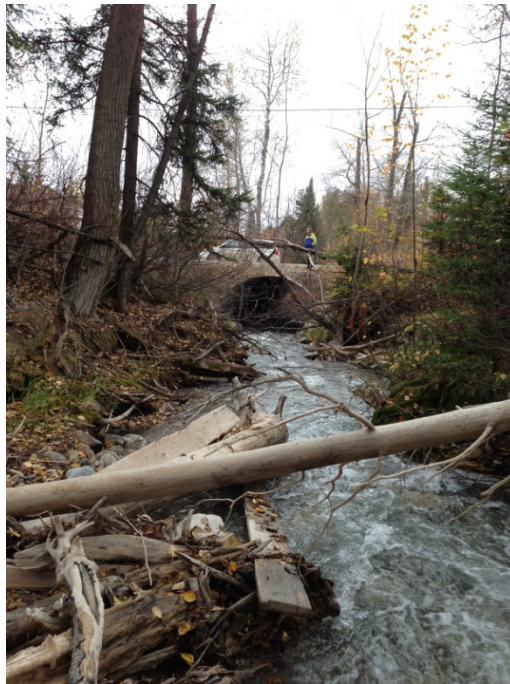
The WLR crossing is a partially embedded circular CMP culvert with a diameter of 4800 mm (**Photo 22**). The downstream end is hanging roughly 0.3 m above the bed; however steep banks and high velocity flow prevented access to verify. A second vertical drop of similar height is located about 5 m downstream of the culvert outlet (**Photo 23**).

**Photo 22.** Downstream view of Windermere Loop Road culvert inlet, Sta. 4+160.

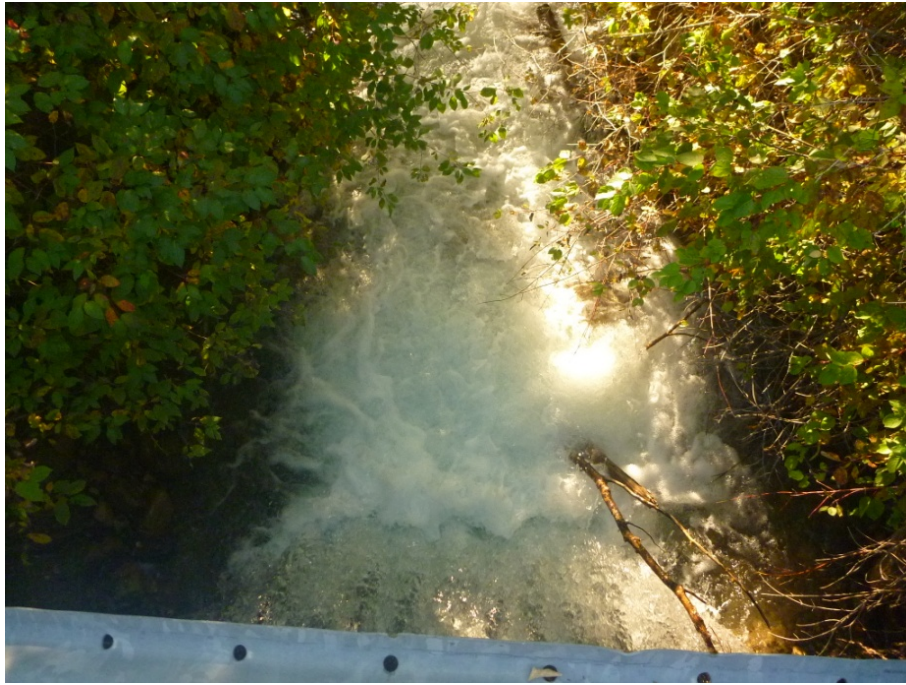
**Photo 23.** Downstream view of Windermere Loop Road culvert outlet, Sta 4+120.

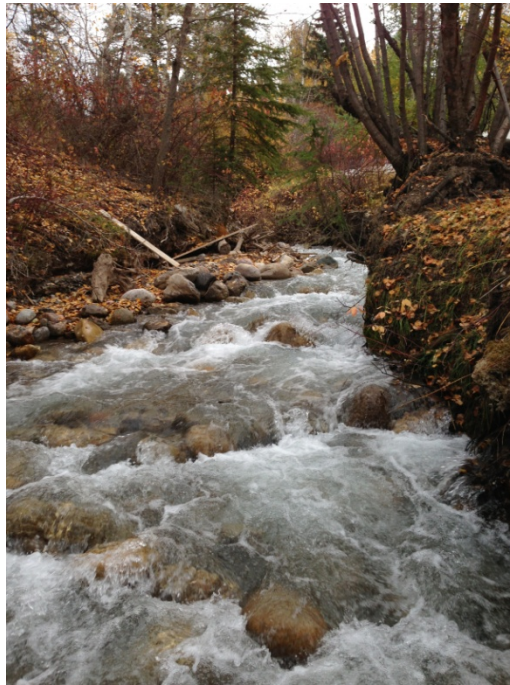
Banks downstream of the crossing are vertical and undercut, with bank height varying from about 2 m at the culvert outlet to 0.3 m about 120 m downstream (**Photo 24**). Channel substrate downstream of the crossing is cobble and small boulders (**Photo 25**). Average channel gradient for the first 100 m downstream of the culvert is 6.5% transitioning to 4% over the next 30 m.

**Photo 25.** Channel substrate downstream of Windermere Loop Road culvert is cobble and small boulders, Sta. 4+000.

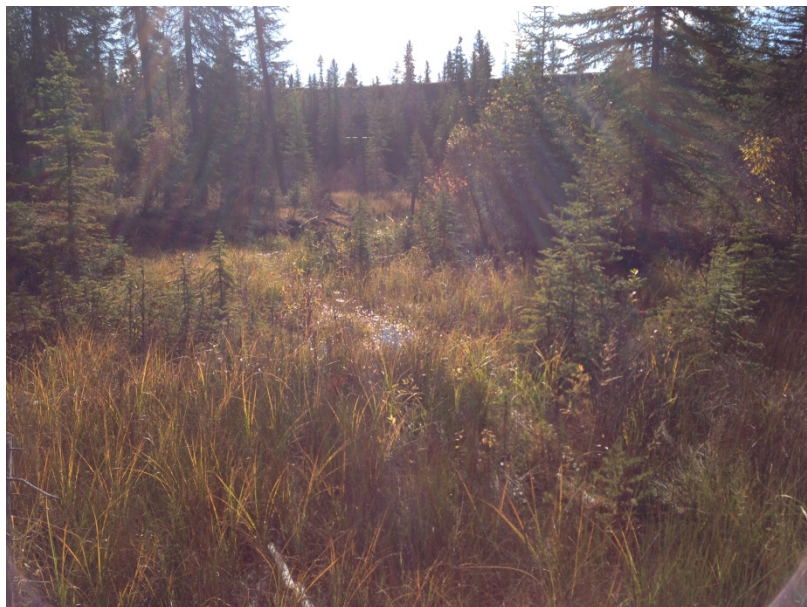
**Photo 26.** Downstream view of vegetation in the wetland on left bank of Windermere Creek upstream of Highway 93 suggests it has existed for a number of years, Sta. 1+700

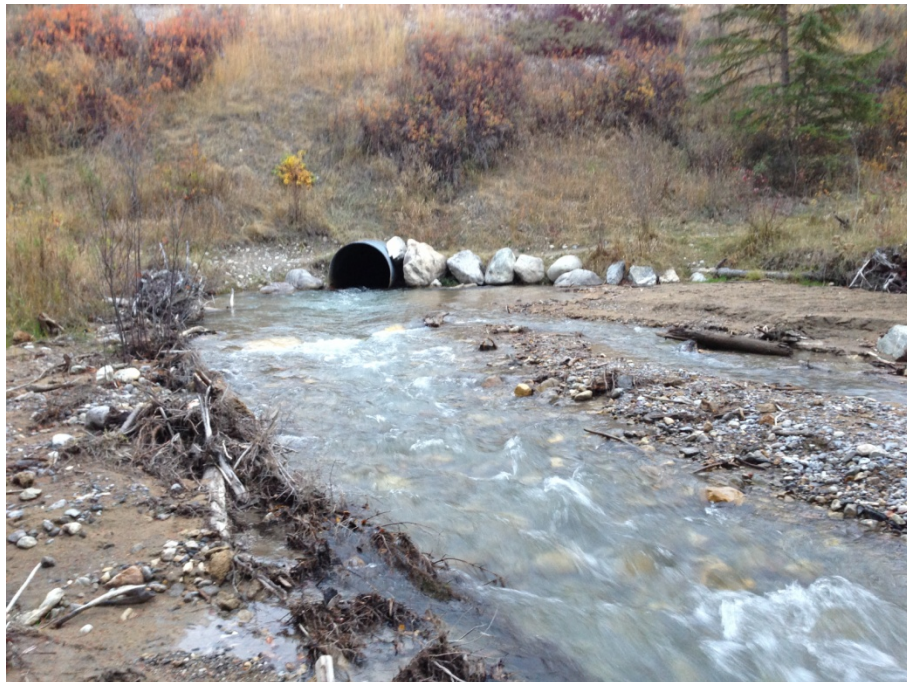
**Photo 30.** Upstream view of Highway 93 culvert outlet, Sta. 1+450.

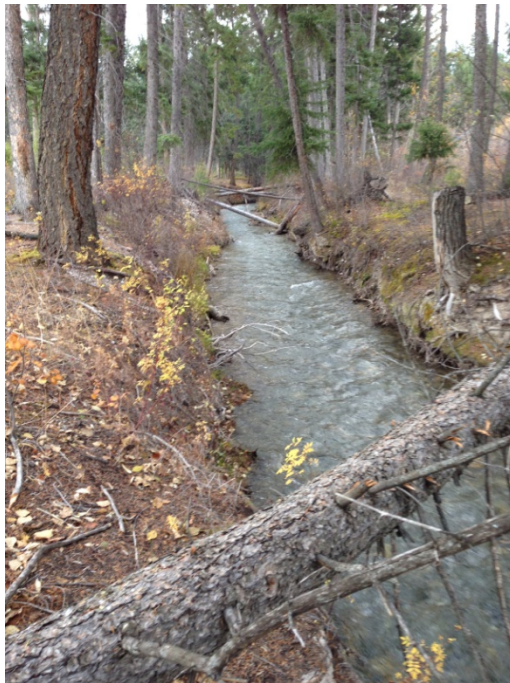
**Photo 32.** Upstream view from Victoria Avenue culvert inlet, Sta. 0+410.

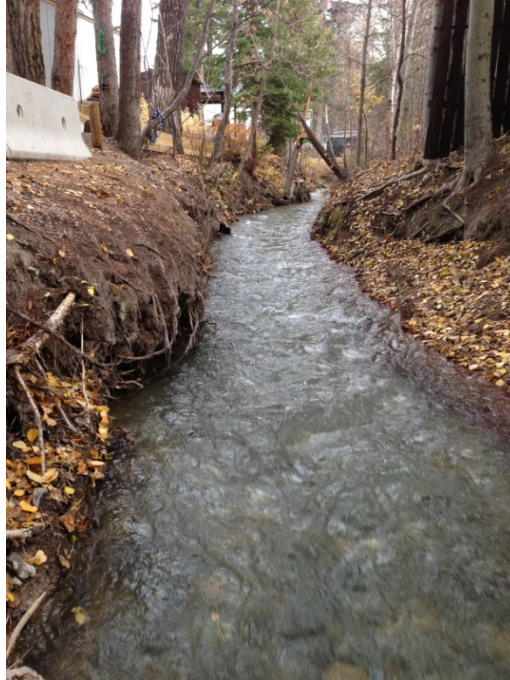
**Photo 34.** Upstream view of confined channel downstream of Victoria Avenue crossing, Sta. 0+370.

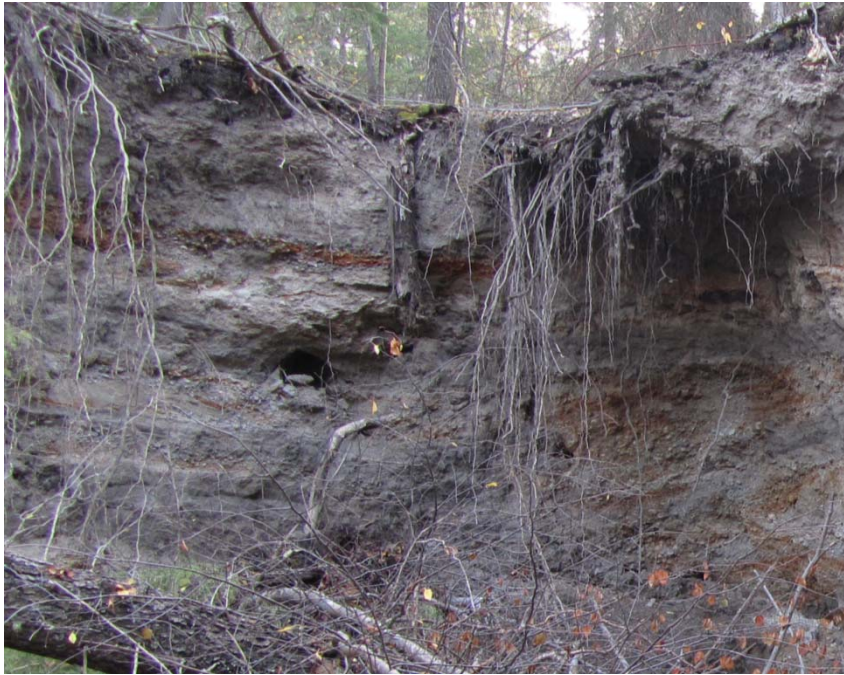
**Photo 35.** Photo of left bank showing buried soil horizons and alternating coarse and fine substrate layers, Sta. 5+300.
